Mill Creek salmonid use

...and what it tells us about habitat suitability

Salmonid Habitat Restoration Priorities Meeting

Sarah Nossaman Pierce, CA Sea Grant

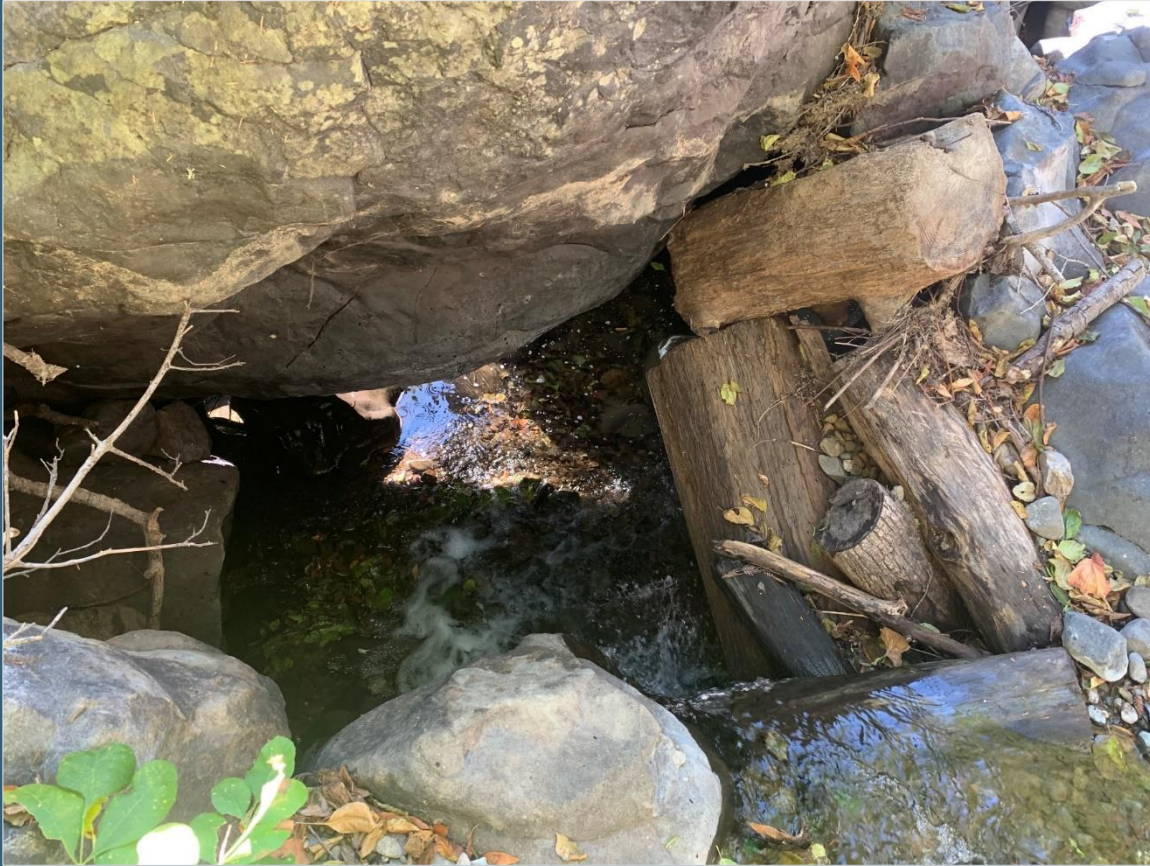
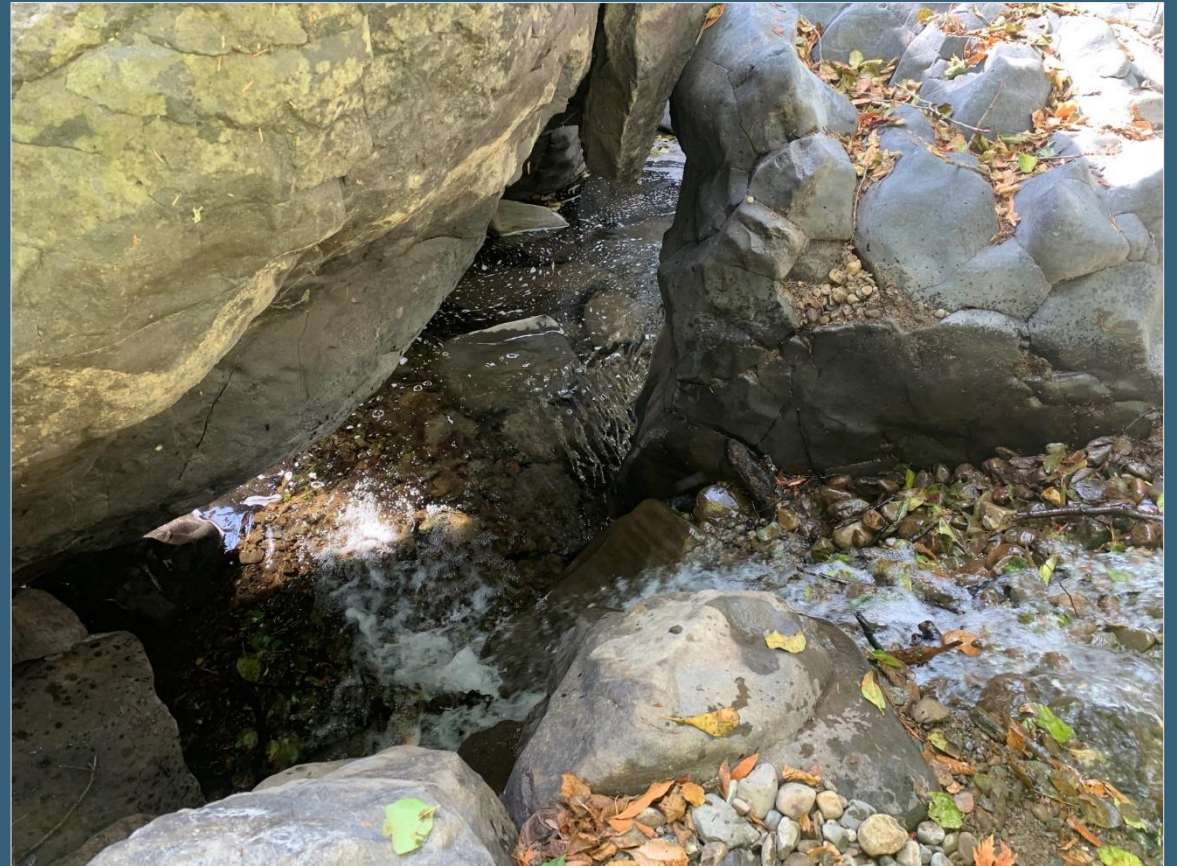
Woody debris blocking passage point at Mill Creek falls

2022 Before

2022 After

- Logs create fish habitat, cut firewood rounds left in the stream cause problems

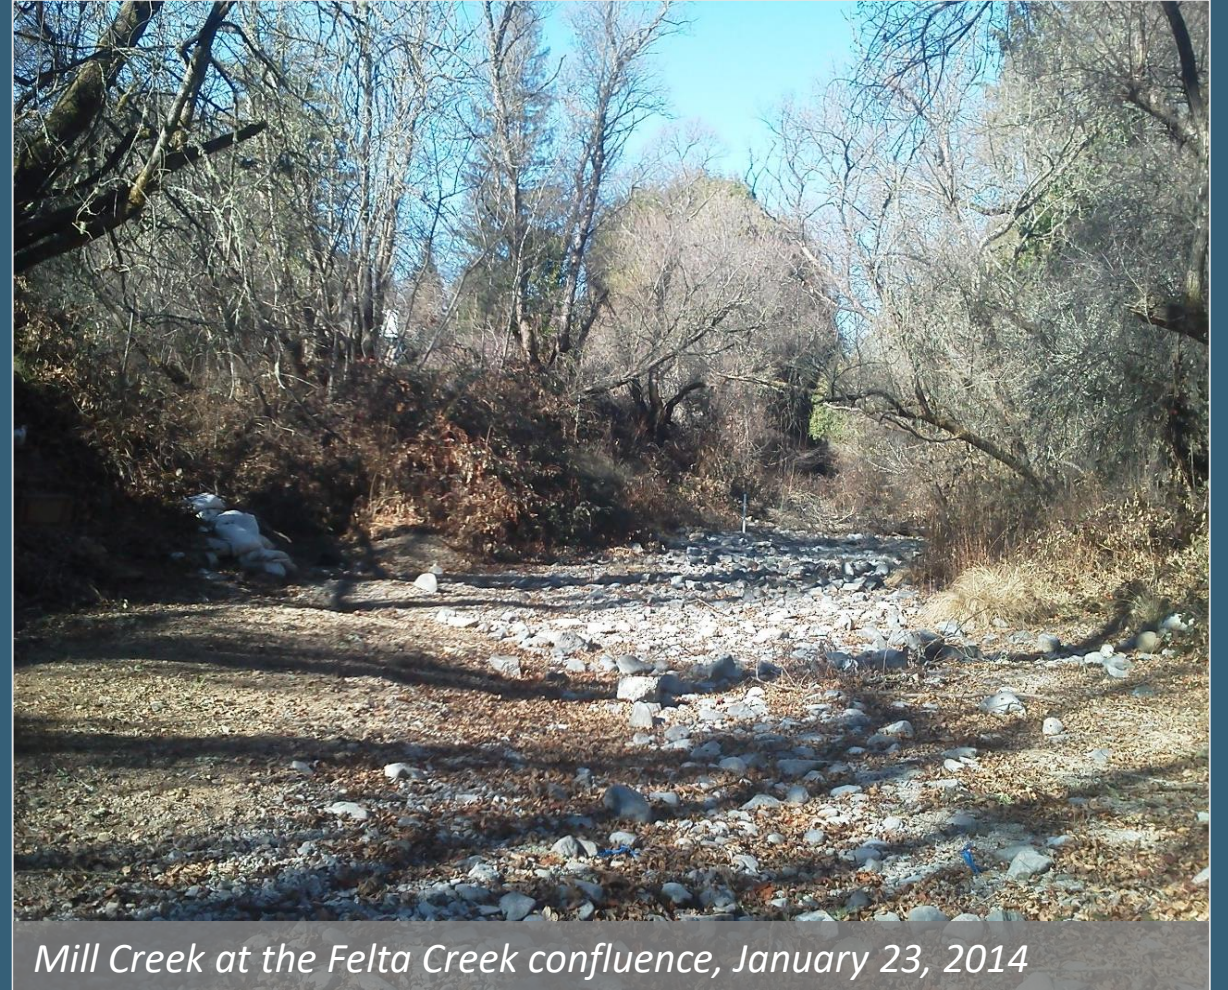
Mill Creek at the Felta Creek confluence, January 23, 2014

- Stream disconnection during coho and steelhead spawning window:
 - Mill Creek closures – 56% of 9 years
 - Felta Creek closures – 89% of 9 years
- Winter drought 2020/21: high % basinwide redds seen in Mill Creek, all adults returned to Mill from other streams
 - Drawn into system by Dry Creek flow?
 - Suggests high importance during dry winters, warrants continued evaluation
- Redds can become stranded prior to fry emergence in dry springs
 - 55% of Felta redds dry/partially dry during 2021/22 spawner surveys

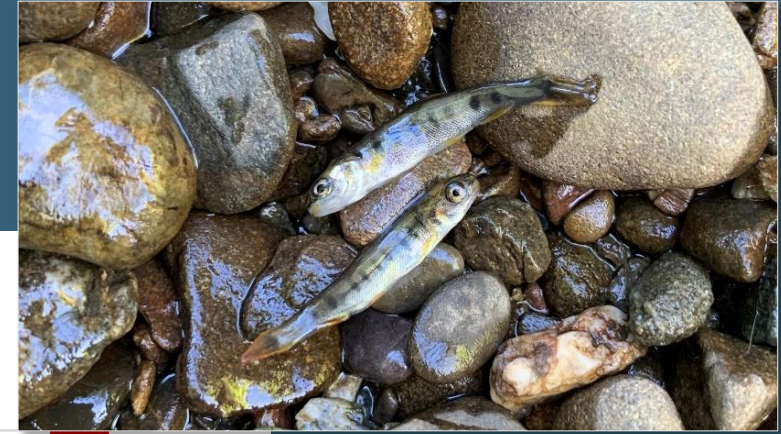
Mill Creek baseflow conditions

Cumulative proportion of surveyed channel that was wet, dry, or intermittent at the driest time of year. Length of channel sampled varied between years.

- 10 year average: 53% of salmon and steelhead yoy in habitat that stayed wet & connected (range 20-76%)
- **2015 (driest):** 20% of fish in wet, connected pools

➤ **11-yr average:** 27% of surveyed channel dry, 8% intermittent, 65% wet & connected

➤ **2015 (driest):** 55% dry, 31% wet & connected

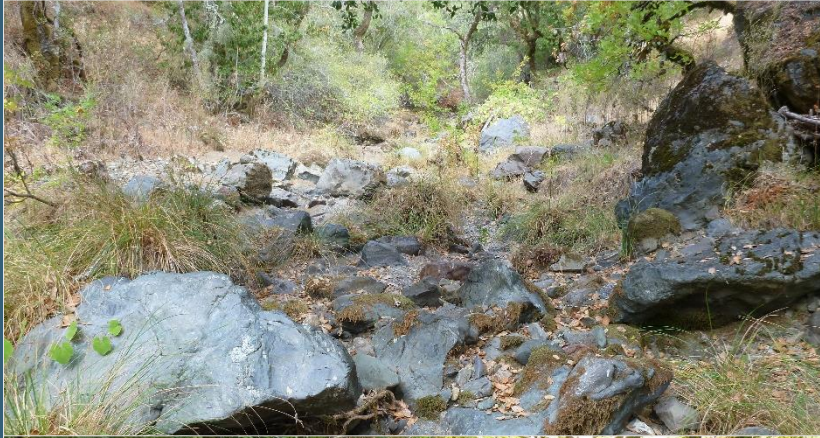
- Wallace Creek
 - Virtually no summer rearing habitat
 - Not contributing summer flow to Mill Creek

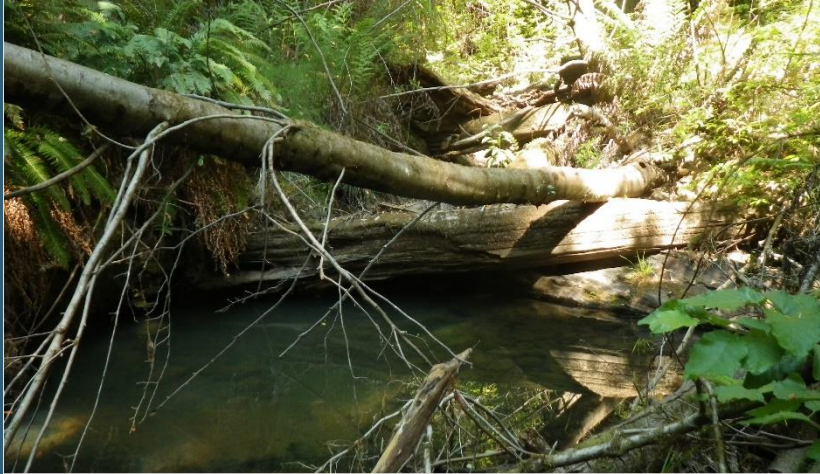
- Felta Creek
 - Middle and upper stretch provides summer rearing habitat, best in wet years
 - Not contributing summer flow to Mill Creek
 - Flow enhancement could improve rearing

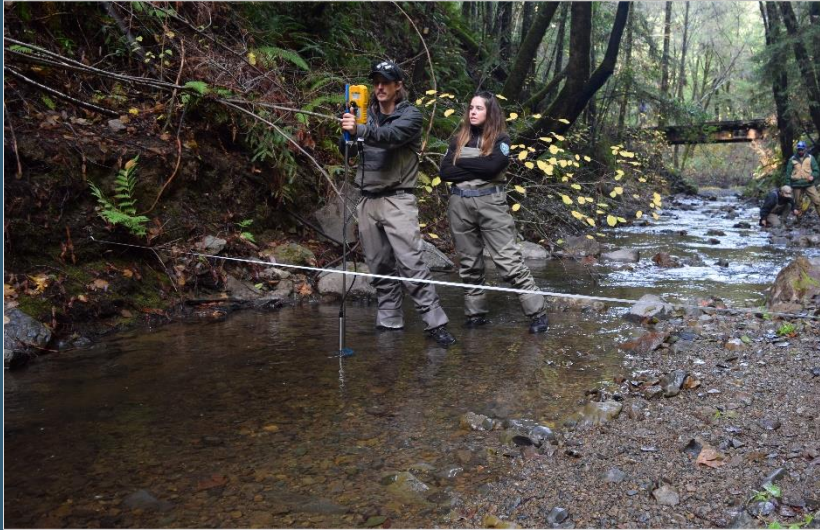
- Palmer Creek
 - Provides summer habitat refugia even in dry years
 - Contributes summer flow to Mill Creek
 - Summer streamflow should be preserved

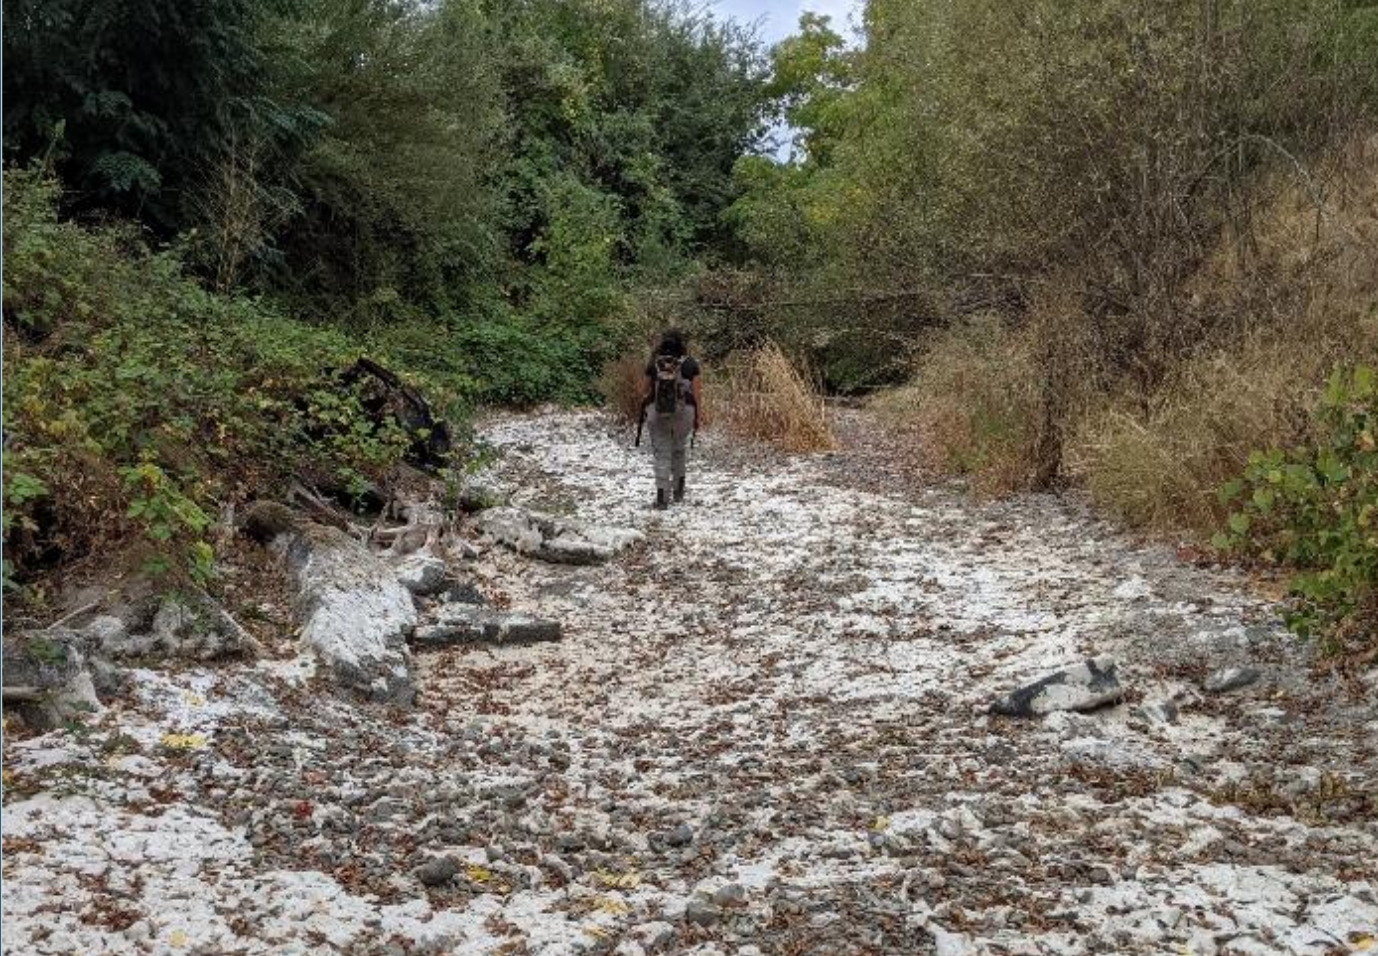
Mill Creek characteristics mouth to falls

- Deeply incised, influenced by Warm Springs Dam
- Trout Unlimited data shows groundwater up to ~15' below summer surface water elevation
- CRWI evaluation shows alluvium >200' deep near mouth
- Likely not possible to restore summer streamflow, but important for smolt outmigration

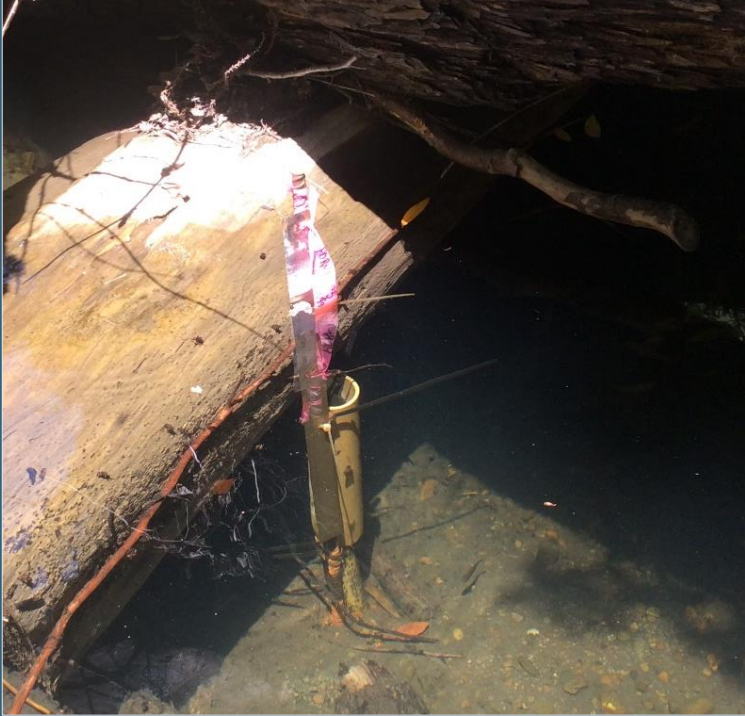
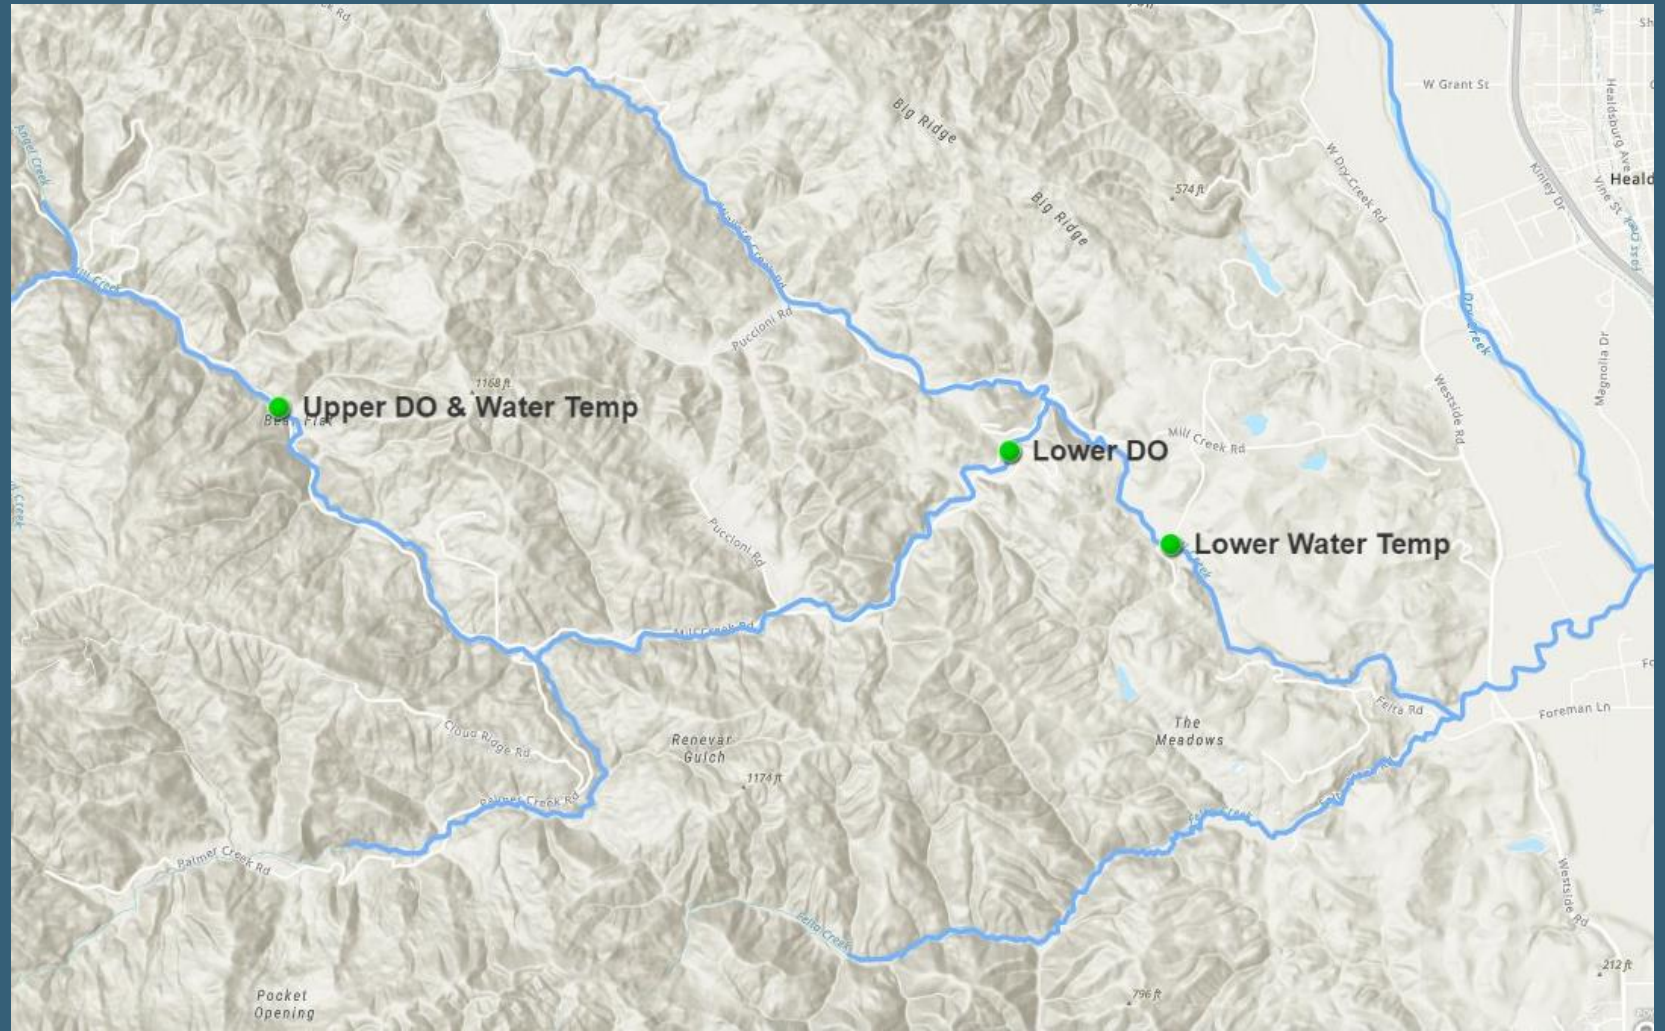
Summer water quality sampling

- 2007-2022 continuous summer water temperature gages, Mill Creek Lane (lower) & Bear Flat (upper)
- 2017-2019 continuous summer dissolved oxygen gages, above Wallace (lower) & Bear Flat (upper)

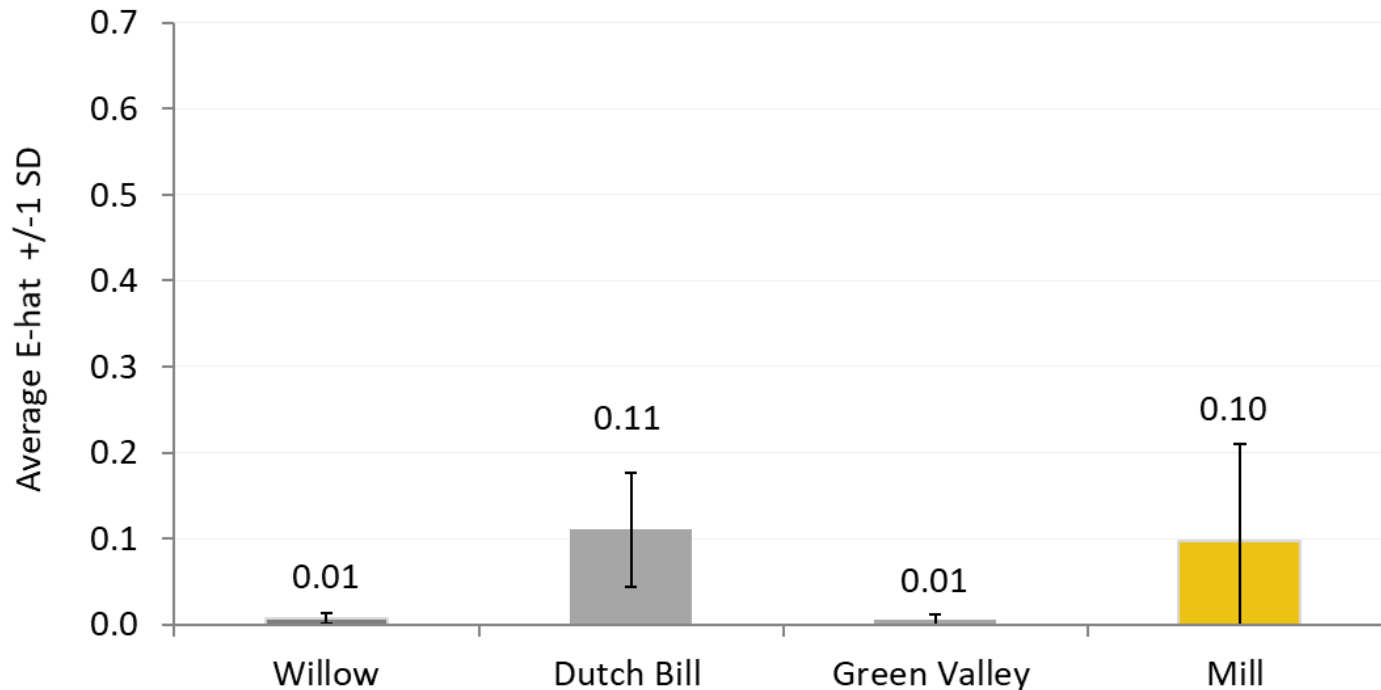
Average proportion of early emigration:
Winters 2012/13-2021/22

Estimated average emigration of fall release hatchery coho out of streams prior to March 1

- Mill Creek high % of smolts emigrate early (pre-spring)
- Generally lower early emigration in winters without large storm events suggests movement not volitional
- Likely influenced by lack of high-flow refugia (complex structure, off-channel habitat) and possibly flow flashiness

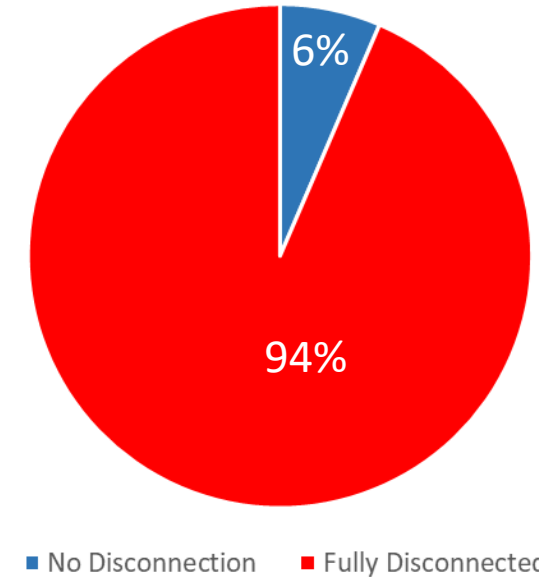
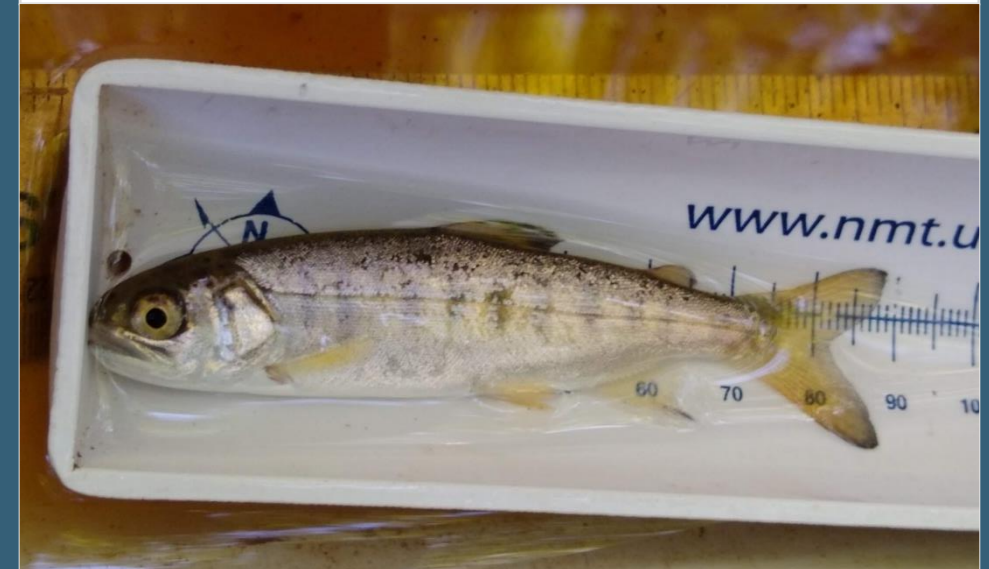
Mill Creek coho smolt trap capture by mouth status: 2021

- Mill Creek 2021:
 - Disconnected prior to peak spring outmigration
 - 94% of smolts entered trap/attempted to emigrate after mouth closure
- UCB/CSG study – decreased streamflow on Mill Creek and other study streams contracted emigration window up to 3 weeks
- CRWI report: *“Flow enhancement efforts intended to sustain or extend the spring flow recession to ensure passable conditions for outmigrating smolts...is one of the most important restoration goals for the watershed”*

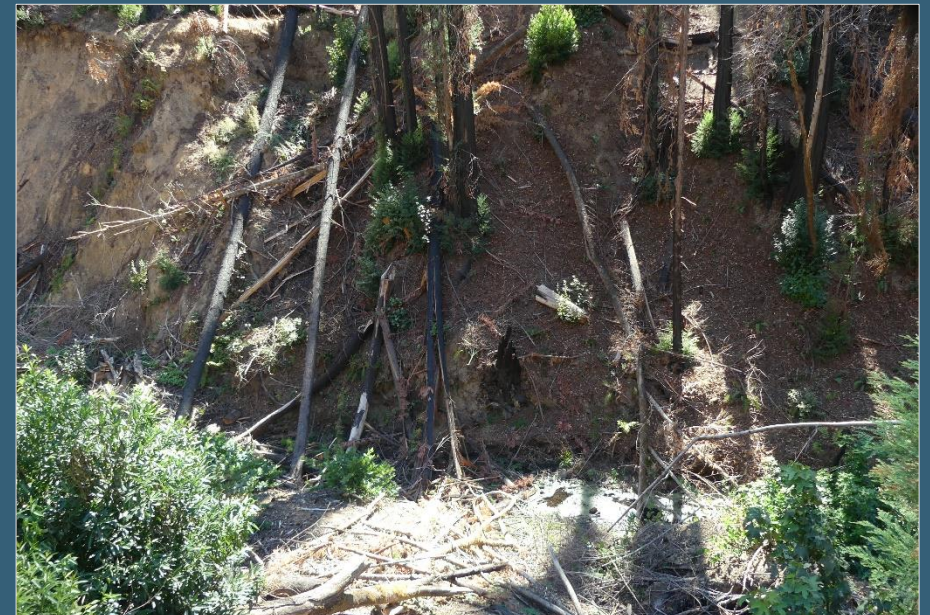
Upper Mill Creek, September 2021

- Small wood debris causing fish passage problems
 - Whole logs in stream channel and on banks should be left to move naturally, not cut into rounds
- Ongoing maintenance/debris clearing is necessary at Mill Creek falls and high-gradient constriction point in lower Felta Creek
- Consider remediation of Felta Creek historic dam structure limiting access to perennial flow reaches, pair with streamflow enhancement in upper reach

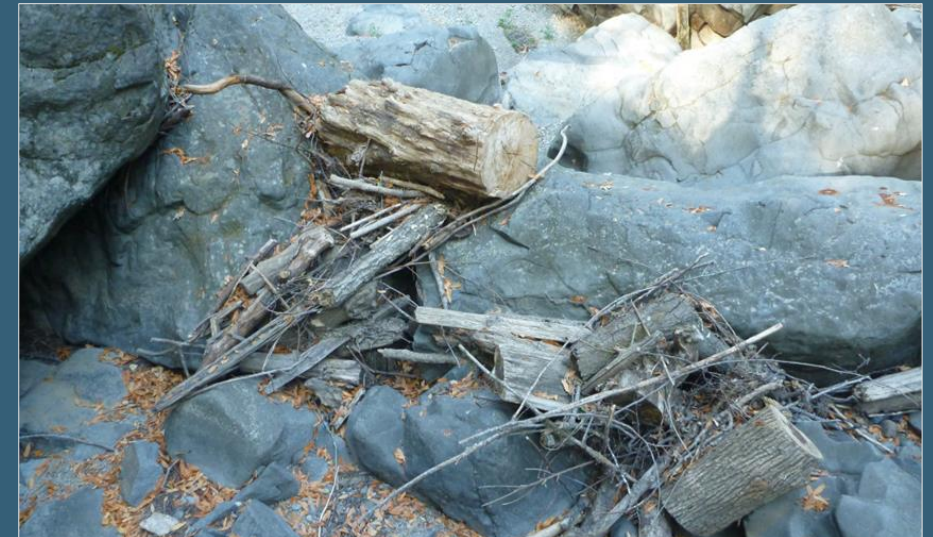
Cut wood blocking passage at Mill falls

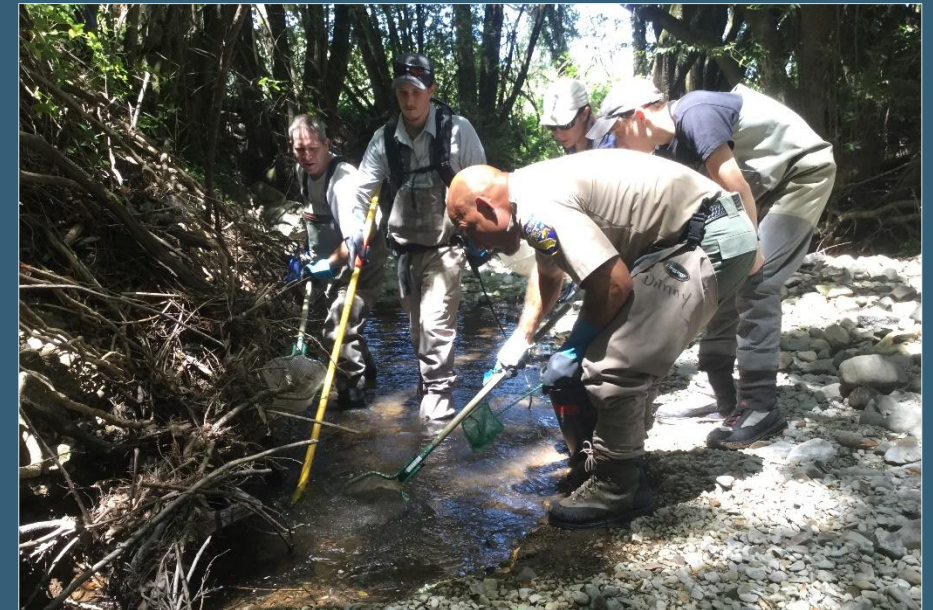
Fish rescue below Felta dam site

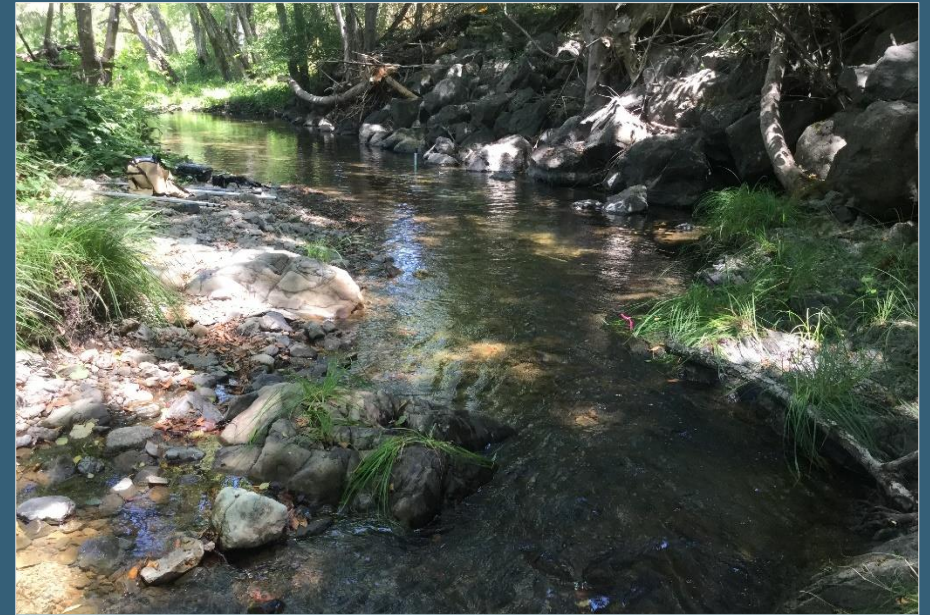
Water quality monitoring site, Mill Creek above Wallace

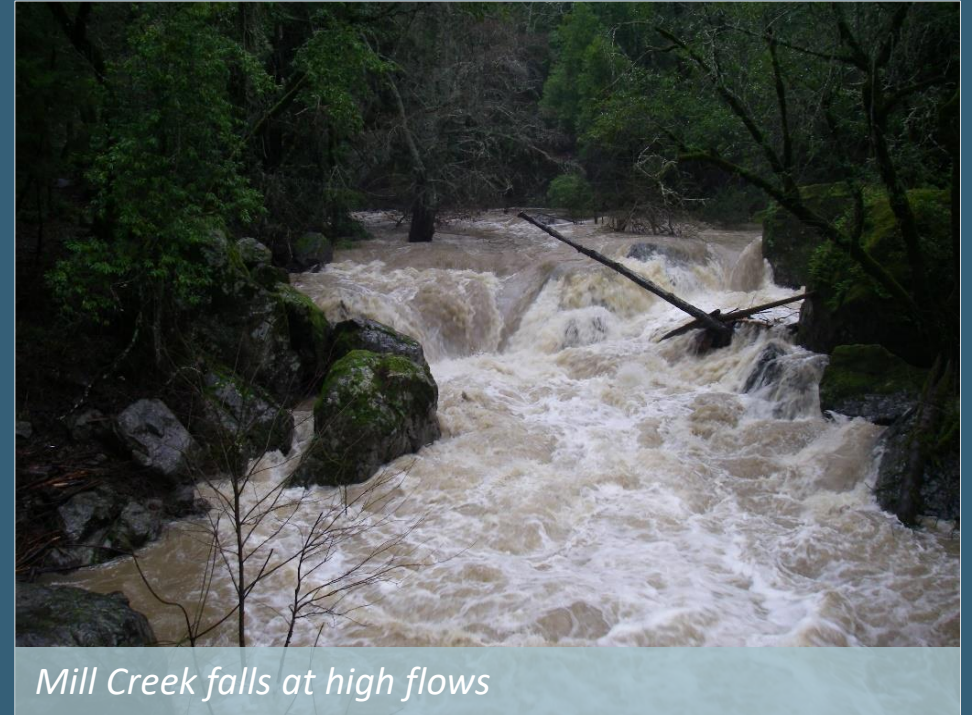
- Flashiness due to alteration of natural drainage patterns may play a role in redd-to-yoy success and early juvenile emigration
- Fire impacts may increase runoff
- Could grow worse under future climate change predictions of fewer, larger winter storms
- Restoring more natural drainage patterns and increasing infiltration could reduce flashiness and help to recharge groundwater

Mill Creek falls at high flows
