Building Climate Resilience of Urban Waters, Ecosystems, and Communities

Final Report for State Coastal Conservancy submitted by Ocean Discovery Institute in partnership with California Sea Grant and San Diego Canyonlands

Project no. # 15-060

Publication no. CASG-18-024

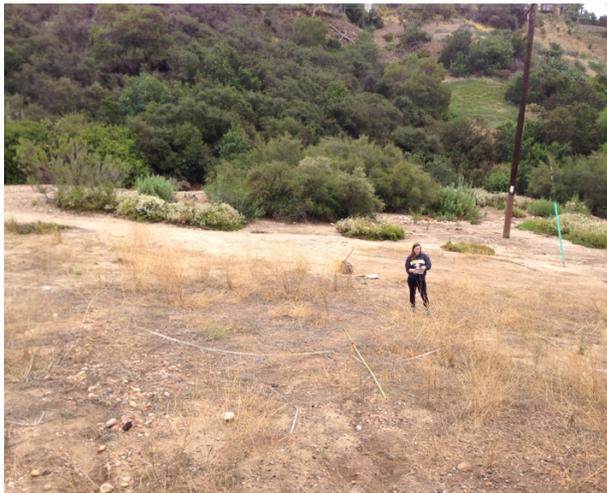
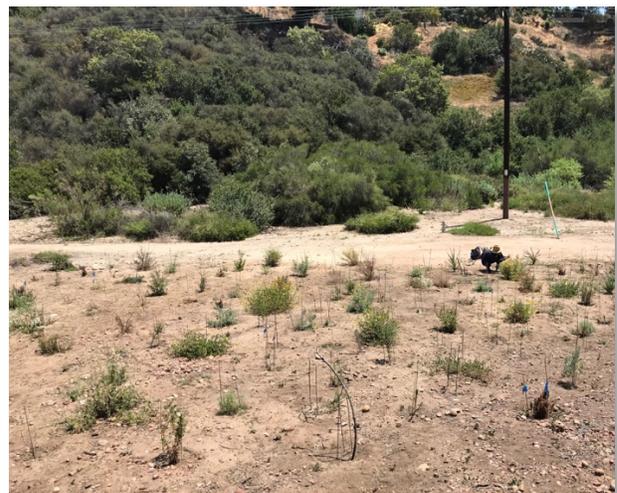
Manzanita Canyon restoration plot MU12 before planting in May 2016 (left), and 6 months after planting in May 2018 (right).

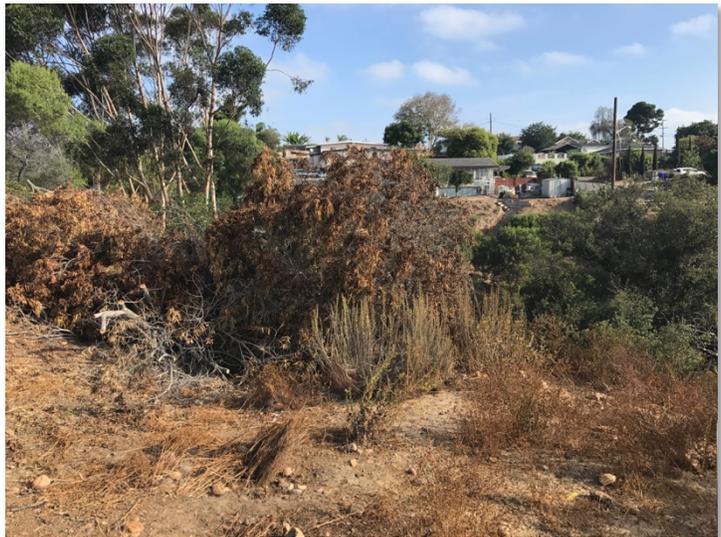
Figure. 1. Renegade trail closure using pruned limbs from nearby maintenance activities placed at the head of a trail leading down a steep slope.

Trail closures. Renegade trails were identified and mapped in the first year of the project. Trail closures occurred opportunistically in both years of the project as large plant material (e.g., cut up fallen tree, brush) became available in close proximity to a renegade trail (Figure 1). Occasionally, cactus or the native woody plantings, if the trail was in a restoration plot, were also planted in trails to discourage use. Brush, woody natives and/or cactus were placed in and across renegade trails in one to several locations, depending upon length of the trail, to block access. Total length of closed trails was calculated using Google Earth with trail GIS layer overlays.

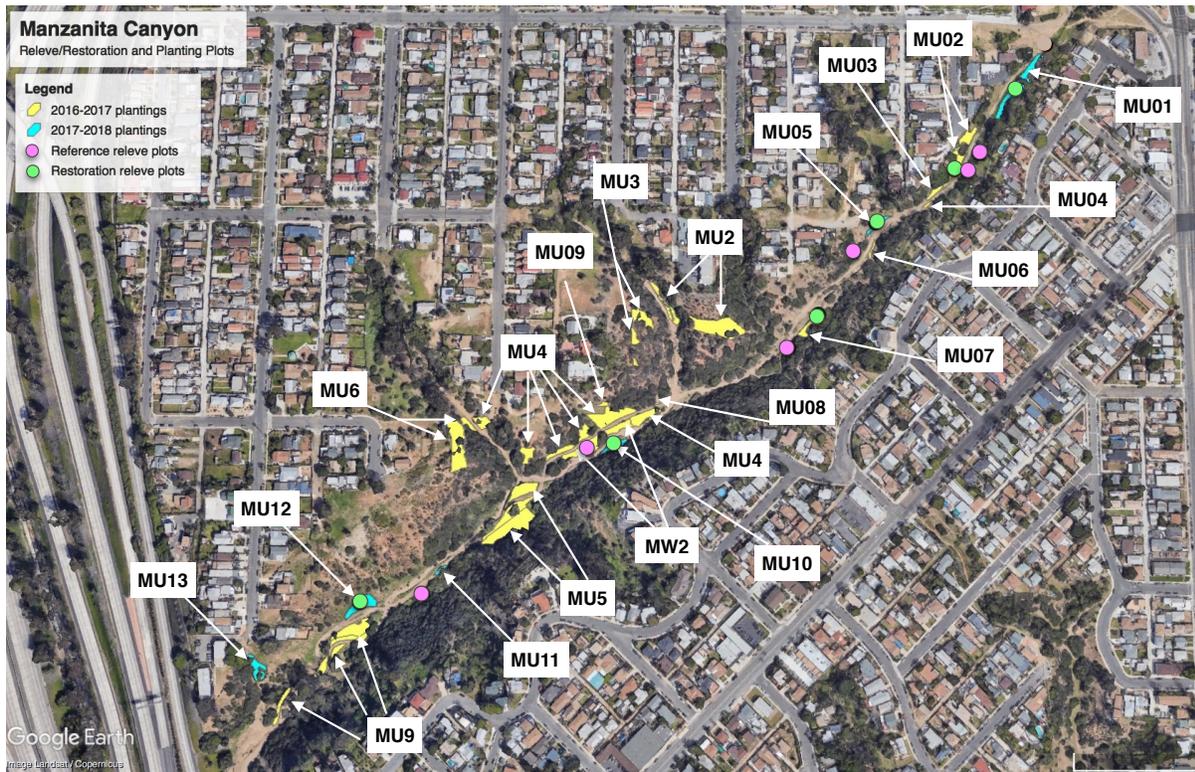
Figure 2. The restoration plots (polygons), and paired restoration-reference plot Relevé survey locations in the 1-km long Manzanita Canyon, San Diego, California. Plots were surveyed between October 2016 – May 2018. Note that MU4 was treated as two plots, one on the canyon floor (coastal sage scrub) and the other along a slope of mixed coastal sage scrub & southern oak chaparral.

Native plantings. Before the start of this project in early 2016, 22 restoration polygons (hereafter “plots”) were established throughout Manzanita Canyon (Figure 2) and a planting palette for each plot was defined based on a combination of criteria, including existing established species, species that are generally common in San Diego canyon ecosystems but that had undergone decline in this canyon, and City regulations (e.g., adherence to Brush Management Zones near residences so that utilities could be maintained). Six nearby reference plots were also established that were similar in topography to the six restoration plots to which they were paired (Figure 2).

A total of 1537 native perennial plants were planted during late 2016-early 2017 (716 plants over 16 plots) and late 2017-early 2018 (820 plants over 6 plots) (Figure 2). Each planting was marked with two bamboo garden stakes (Figure 3) and, for the first 2-3 months, surrounded by a plastic cylinder (Figure 4) to prevent herbivory. The restoration plots varied in area, species planted, and numbers of plantings (Appendix 1).

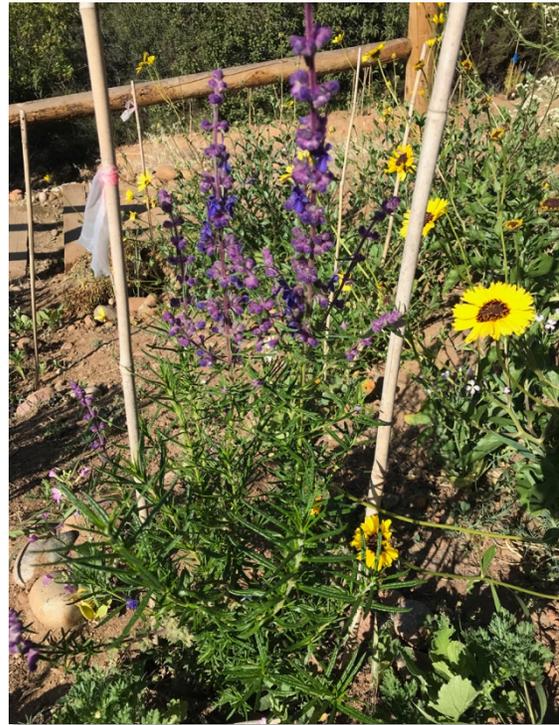
Figure 3. A planted *Trichostema lanotum* marked with two bamboo garden stakes in plot MU13, May 2018.

Planting Growth and Survival. At least 10% of each planting species in each plot were tagged for monthly measurements of growth. Throughout October 2016- February 2017 (year-1 plantings) and October 2017-May 2018 (year-2 plantings), basal stem diameter of each tagged plant was measured using a caliper placed at the soil surface level. The volume of the tagged plants was measured by measuring height the tallest point of the plant, length at the widest diameter of the plant, and width of the diameter perpendicular to length.

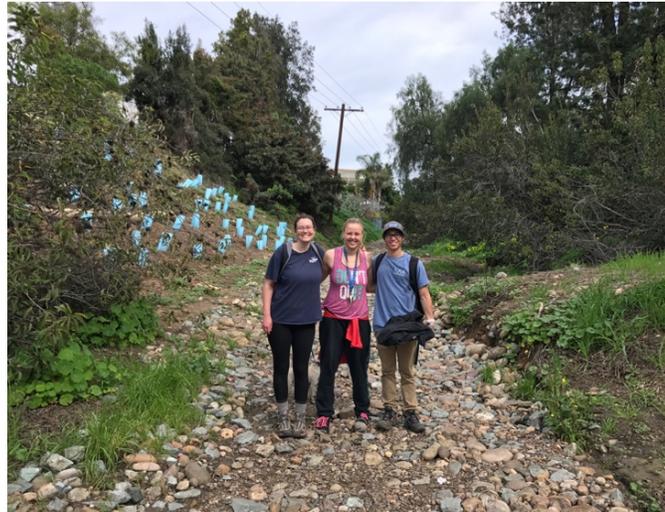
Figure 4. Project team members, Nina Venuti, Blanka Lederer & Charles Adams next to recently planted plot MU02 revealing blue cylinders placed over new plantings to deter herbivory; Feb 2017.

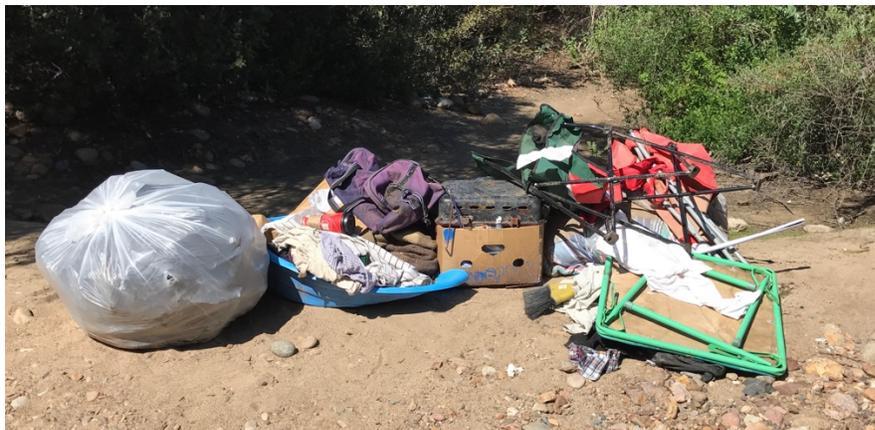
Figure 7. A typical example of large trash items found throughout Manzanita Canyon; pictured here are folding chairs and table, gas stove, suitcase, kids pool, broom, clothes, and a bag with trash and blankets found on 09 March 2017 at the base of Jamie’s Way access trail.

Canyon-wide trash. Over the two-year long project, roughly 12.95 metric tons of trash and debris (137.5 m³) were removed from the canyon by the project team and community volunteers. Included were bags of mesotrash and an assortment of large items, mostly commonly furniture (e.g., couches, chairs, mattresses, headboards, desks), household items (e.g., fans, lamps, carpets, suitcases, mirrors, microwave ovens, toilets, a tub, a water heater), and shopping carts and strollers (e.g., Figure 7).

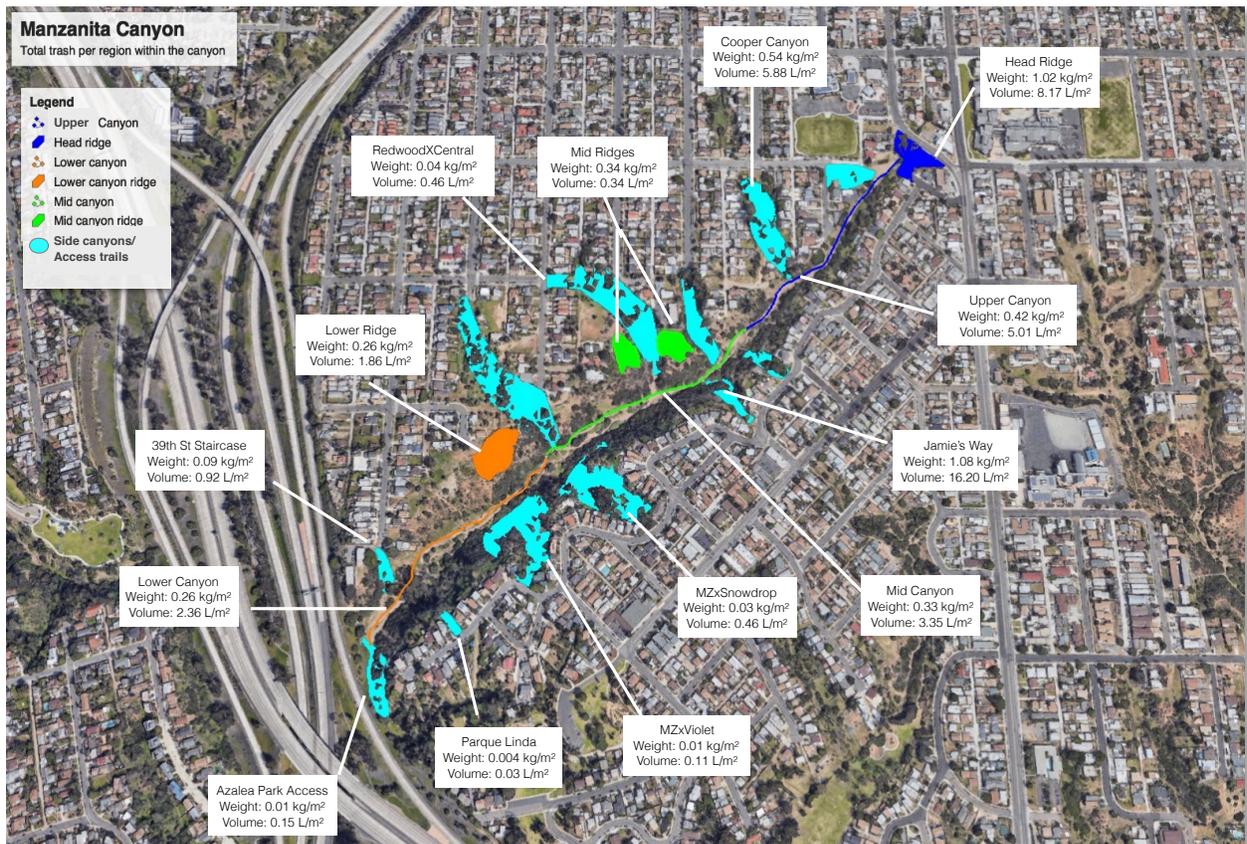
Figure 8. Regions within the 1-km long Manzanita Canyon with total trash removed from May 2016-May 2018.

Trash by canyon region. In general, trash accumulations were greatest at the upstream end of the canyon (“upper canyon”) and decreased with distance downstream (Figure 8). The highest abundance of trash was removed from the side canyons and access trails in the upper half of the canyon (Figure 8); roughly 0.54 kg/m² (5.9 L/m²) of trash was removed from Cooper Canyon (Figure 8) with illegal dumping the likely main source based on the items found, such as car engines, furniture, and cement. Jamie’s Way, which also serves as an access trail into the canyon, was cleared of 1.1 kg/m² (16.2 L/m²) of trash (Figure 8), with likely sources from homeless encampments based on common items found, such as cookware, bedding, camping gear (e.g., Figure 7). The ridge at the upper canyon, including Manzanita Gathering Place and the access trail leading into the canyon, was cleaned of 1.0 kg/m² (8.2 L/m²) of trash, with homeless and illegal dumping as likely sources based on common items, including shopping carts, furniture, and bedding. On the canyon floor, the upper end of the canyon accumulated the greatest amount of trash (0.42 kg/m²; 5.0 L/m²; Figure 7) due to storm drain inputs and illegal dumping based on items found (e.g., loose trash downstream of the storm drain, abandoned mattresses and furniture by the entrance).

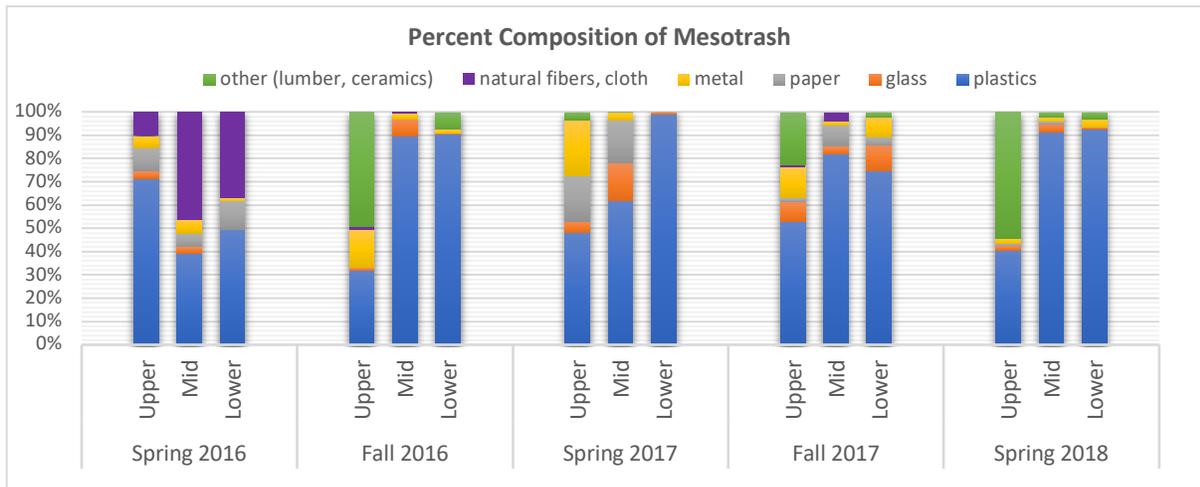
Figure 9. Percent composition by volume of mesotrash collected biannually along three transects located at the head (upstream), mid-reach (mid) and downstream end of Manzanita Canyon between Spring 2016- Spring 2018.

Mesotrash composition. By volume, mesotrash was nearly always dominated by plastics (33-98%), whether across location in the canyon (upper, middle or lower end) or across season and year (Figure 9). Sporadically, the influence of illegal dumping was obvious with patchy

occurrences of building and household materials (e.g., lumber, particle board, ceramics, bedding) (Figure 9).

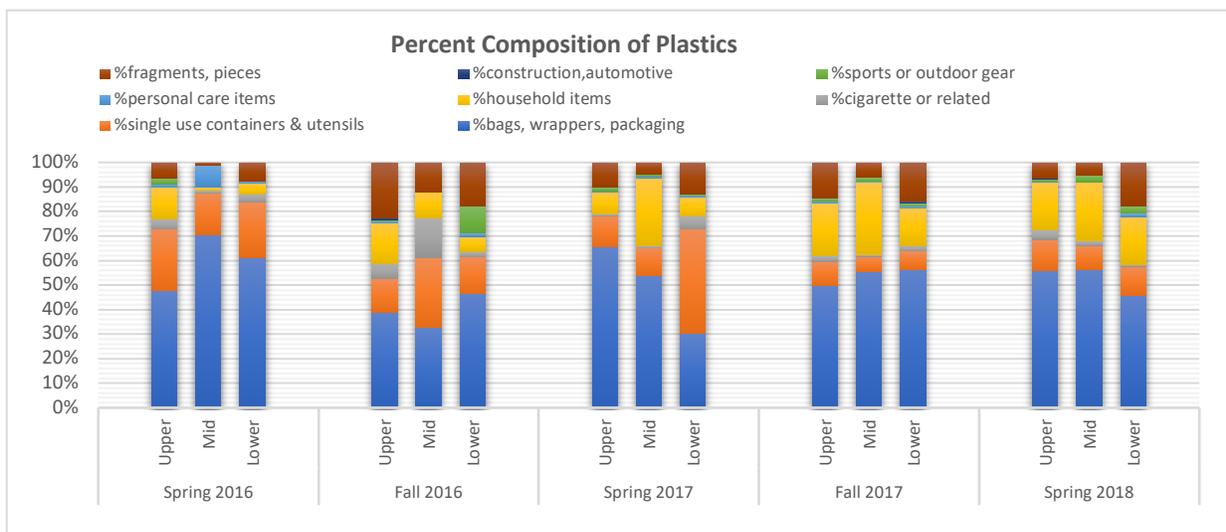
Figure 10. Percent composition by number of mesoplastics collected biannually along three transects located at the head (upstream), mid-reach (mid) and downstream end of Manzanita Canyon between Spring 2016- Spring 2018.

Mesoplastics composition. Mesoplastics were consistently, in space and time, numerically dominated by bags, packaging, and wrappers, comprising an average ($\pm 1SE$) of $51\pm 3\%$ of all plastics (range of 30-70%; Figure 10). Also common were single-use containers and utensils (6-43% of mesoplastics), household items (e.g., cleaning solution jugs, pens, synthetic cloth/wipes, laminate, carpet fibers, broom bristles; 1-29%) and plastic fragments (1-23%) (Figure 10).

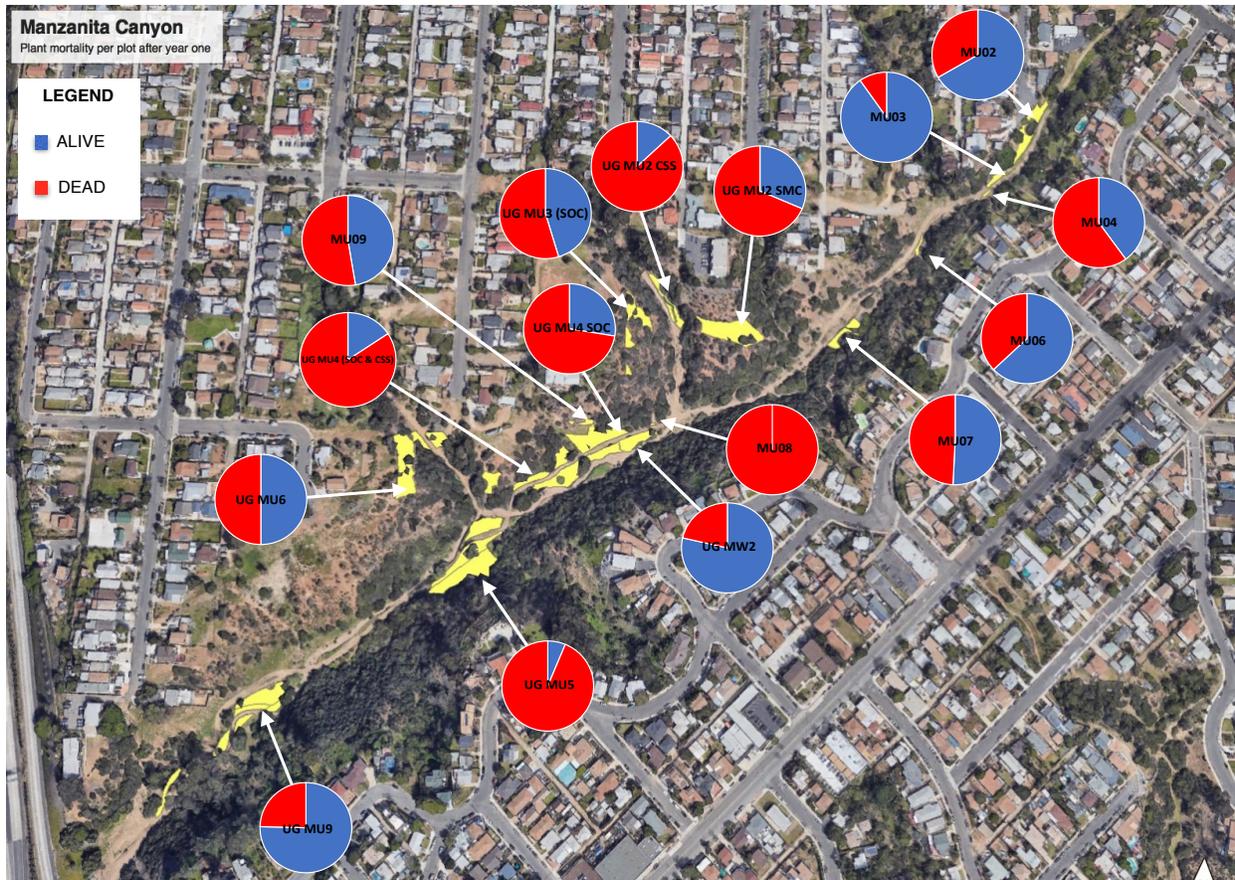
Figure. 11. Planting survival and mortality in the year-1 restoration plots of Manzanita Canyon. Natives were planted between October 2016-February 2017, and data were collected from Oct 2016-January 2018. N= 716 plants over 16 plots.

Survival After One Year. There was 50% survival of plants at one year after planting, ranging from 0% (MU08) to 90% (MU03) survival across the 16 plots (Figure 11).

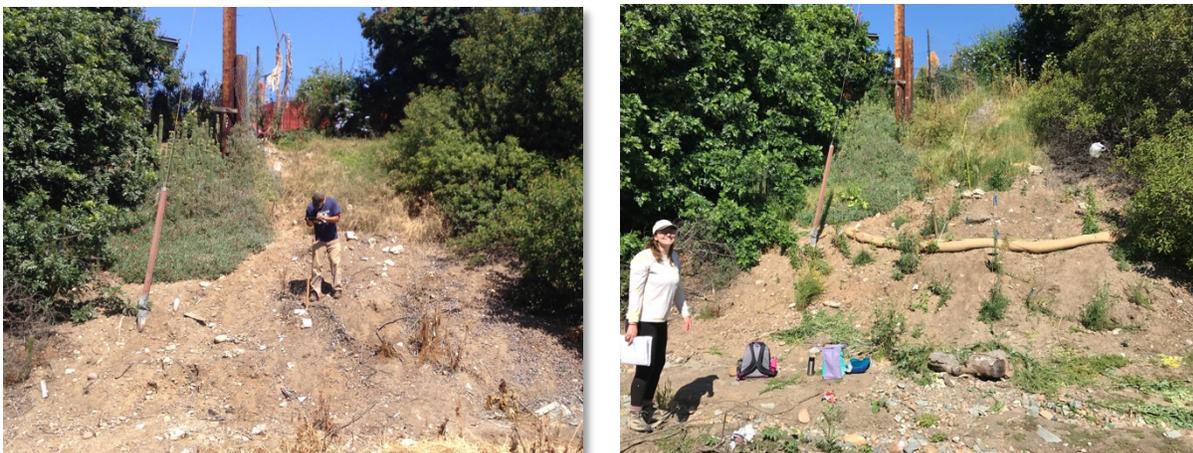
Figure 12. Manzanita Canyon restoration plot MU02 in May 2016, before planting, and in April 2017, 3 months after planting.

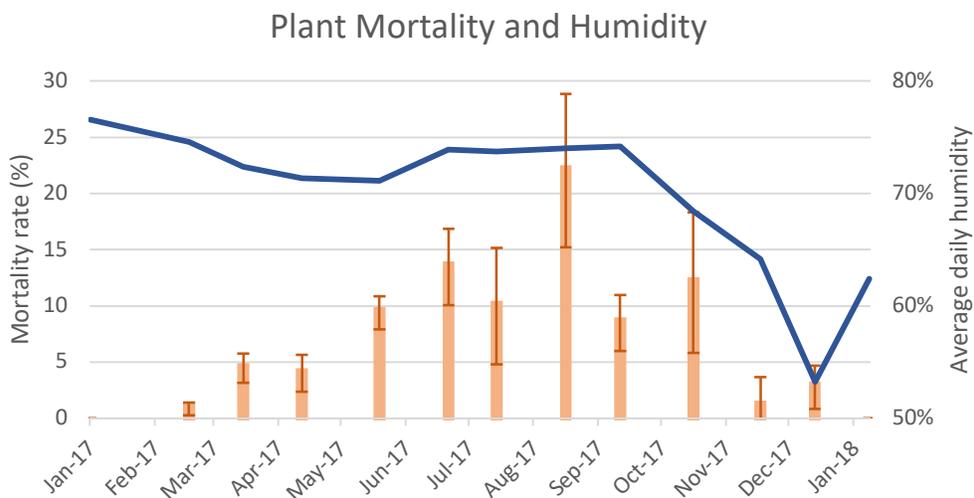
Figure 13. Native planting mortality rate (% monthly change in mortality, orange bars) and average daily humidity (averaged within sampling month, blue line) throughout year-1 of the Manzanita Canyon restoration project. Humidity was the only variable tested that was correlated with monthly mortality rate (see text). N= 16 restoration plots.

Monthly mortality rates of all species of year-1 plantings were weakly but significantly negatively correlated with maximum daily humidity over the first year (Table 1, Figure 13). Planting growth (% change in volume each month) was weakly but significantly positively correlated with total daily rainfall averaged over the month (Table 1, Figure 14). Growth, measured as change in stem basal diameter was weakly but significantly negatively correlated with daily maximum dew point averaged over the month (Table 1).

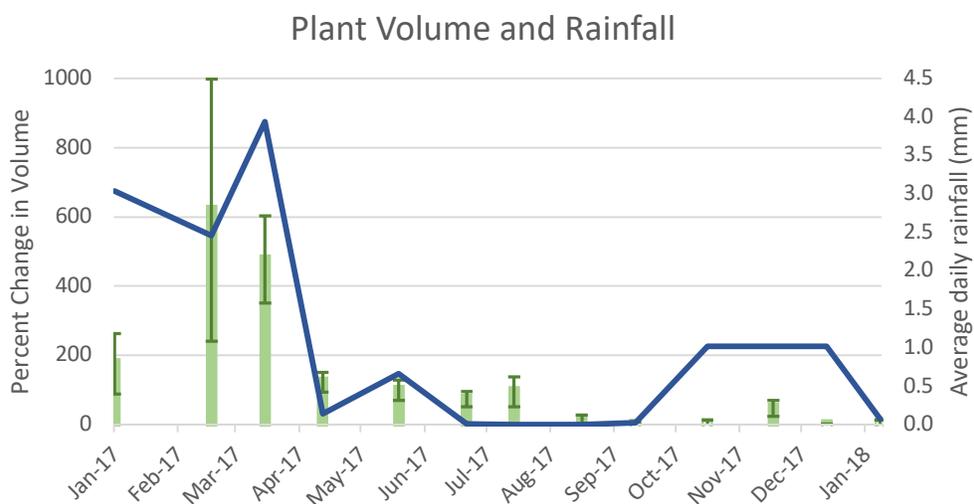
Figure 14. Native planting monthly growth rate (% monthly change in volume, green bars) and average daily rainfall (averaged within each sampling month, blue line). Average daily rainfall was the only variable tested that was correlated with planting growth (see text). N= 16 restoration plots.

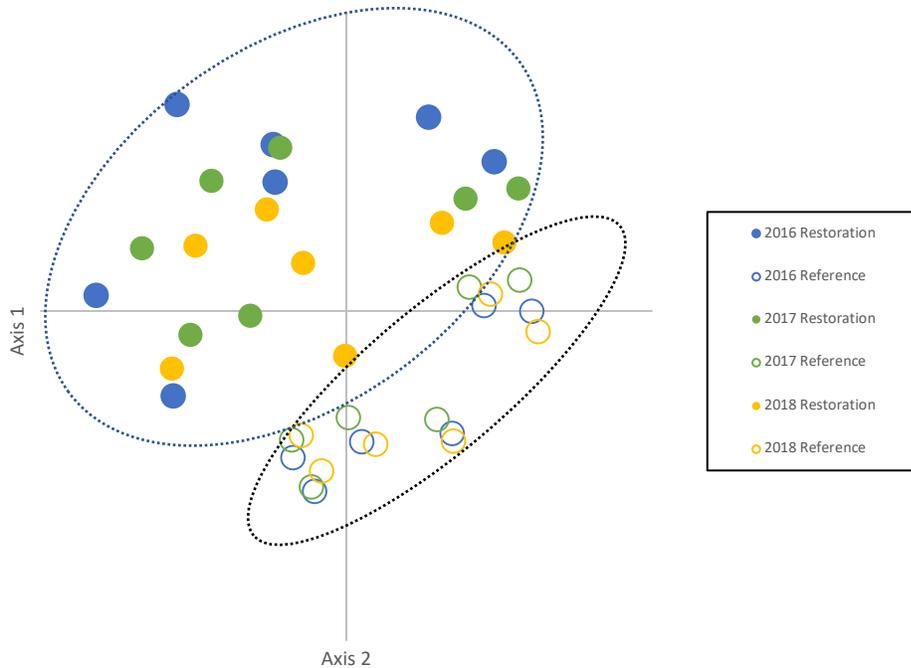
Figure 15. nMDS showing differences in the plant community composition of restored and reference plots of Manzanita Canyon from 2016-2018 (n=6 plots each, Stress=0.18).

The plant communities in the restoration and reference plots differed from each other within and across years. Plant community did not differ with time within the reference plots, but did differ in the restoration plots between 2016, before planting began, and 2018, after completion of planting (Figure 15, Table 3). [Note that in 2017, only half the restoration plots- MU02, MU07, MU10 were planted]. Plant communities within the restoration plots were less similar (more variable) than within reference sites in any given year (Table 3, diagonal); however, similarity in the restoration plots increased each year as the native plantings were completed (from 12% similarity in 2016 to 18% in 2018; Figure 15, Table 3).

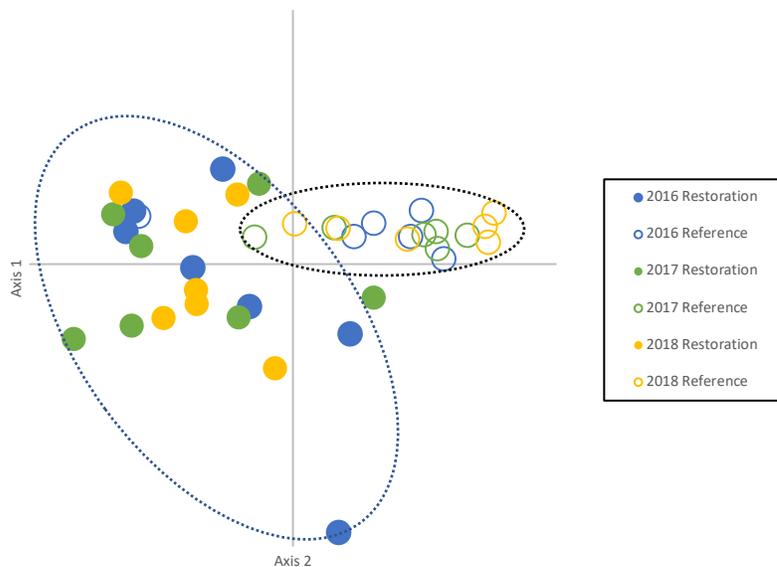
Figure 16. nMDS showing differences in the substrate composition of restored and reference plots of Manzanita Canyon from 2016-2018 (n=6 plots each, Stress=0.10). See methods for the variables assessed.

There were differences in substrate composition between the restoration and reference plots within and across years, while substrate did not differ with time within the restoration or reference plots (Figure 16, Table 4).

Substrate conditions within restoration plots were less similar (more variable) than within reference sites in any given year (Figure 15, Table 4). Substrate composition between restoration and reference plots was 34-39% different (Table 4) due to a less cover by litter, and greater cover of exposed fine sediment and coarse material (gravel and cobble) in the restoration compared with reference plots. Restoration plots also had a higher cover of basal stem area in 2016 and 2017 due to the often-high density of annual invasive plants (SIMPER variables explaining $\geq 75\%$ of the variability between plots types within years).
