# Dam Remediation Improves Fish Passage on Mill Creek

## Flashboard Dam Identified as Bottleneck to Coho Recovery

### Mill Creek Dam Fish Passage Project

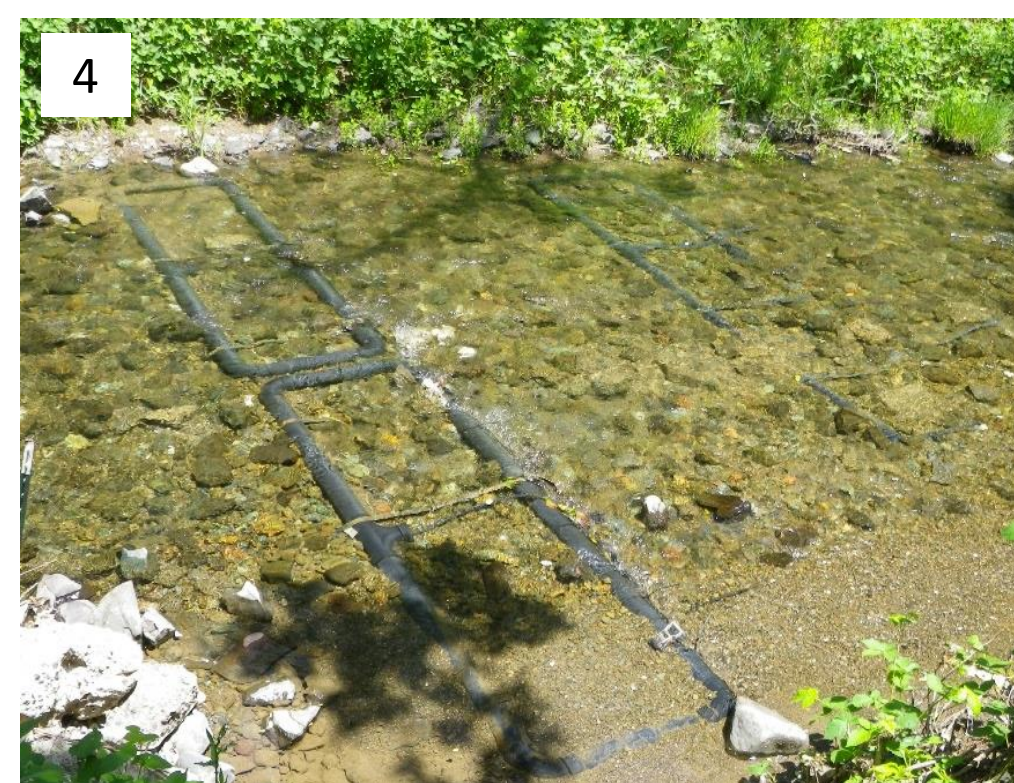
**Figure 2-3.** Adult spawner surveys were conducted approximately every two weeks on Mill Creek, each winter since 2011, to document fish presence and redd distribution above and below the dam.

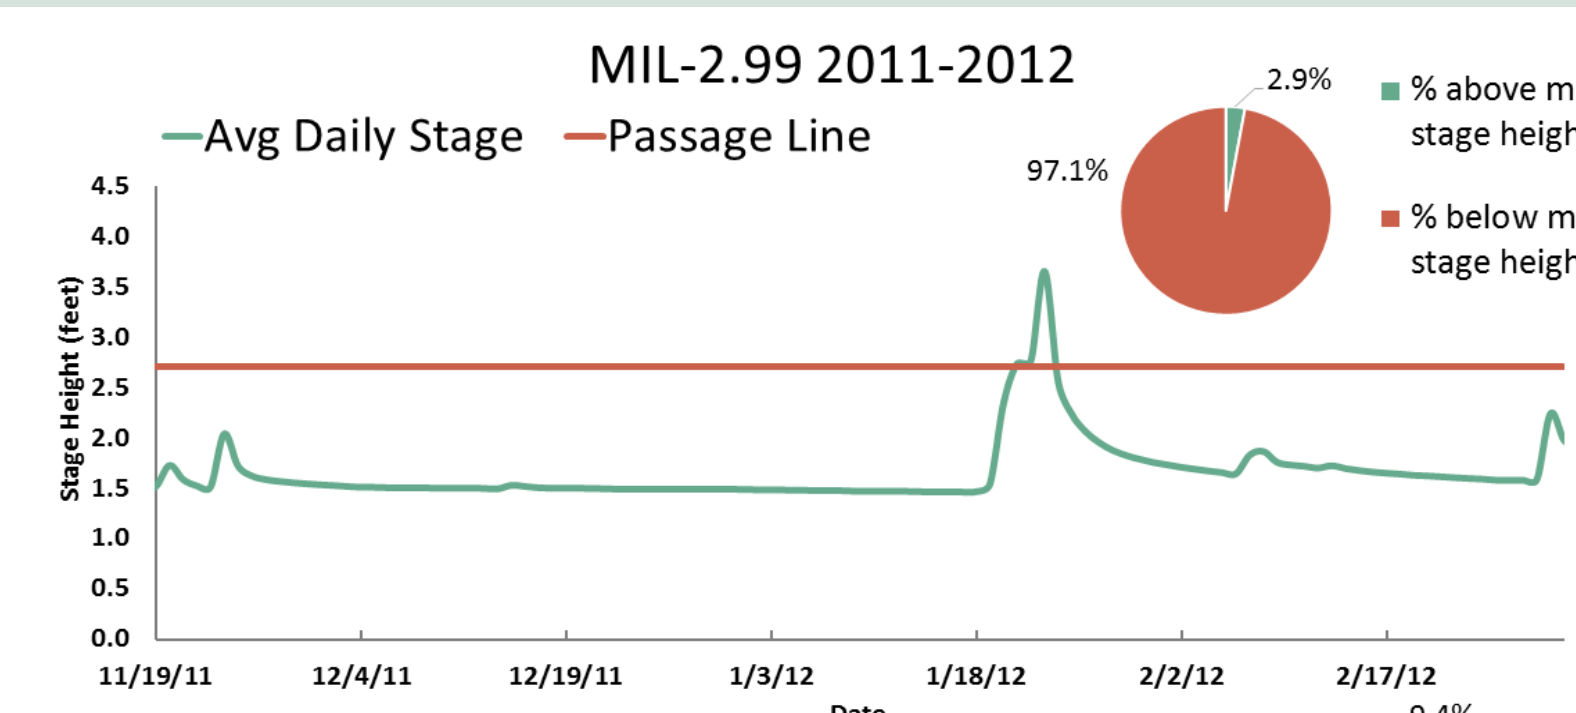
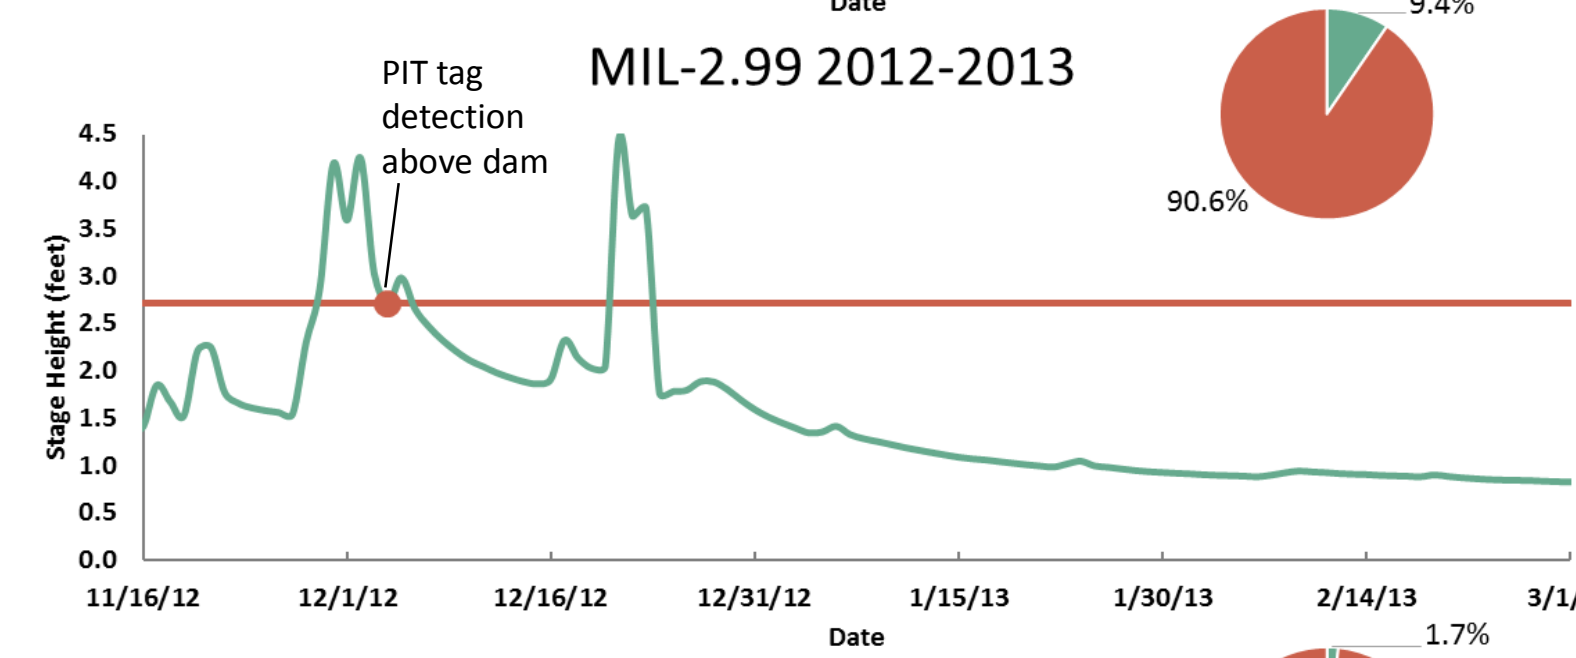
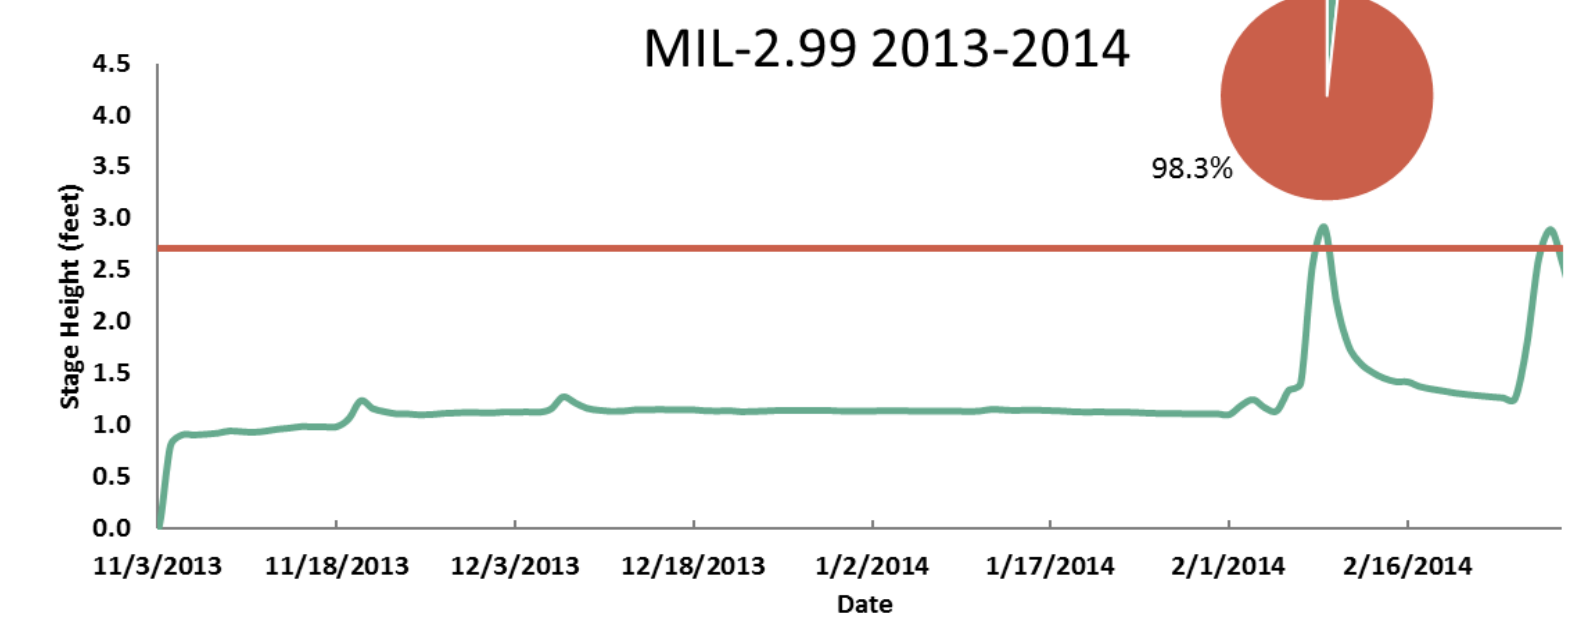
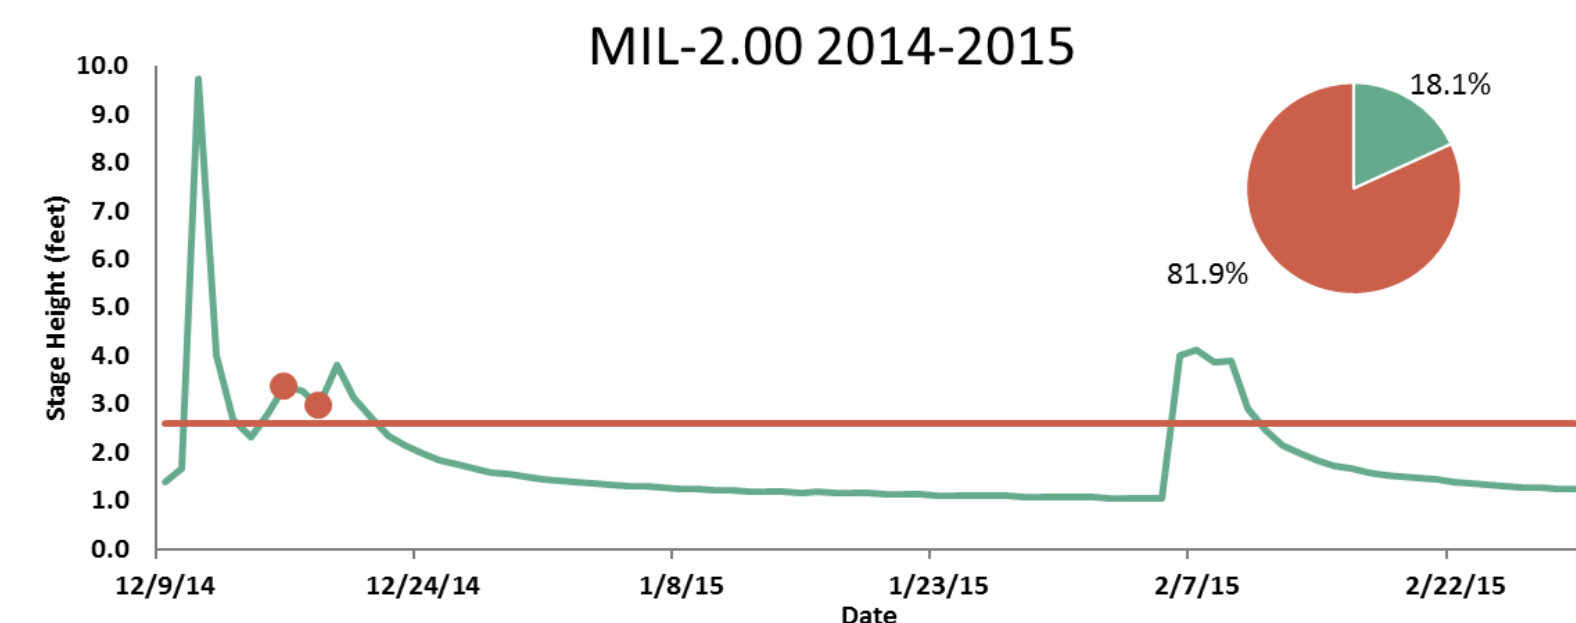
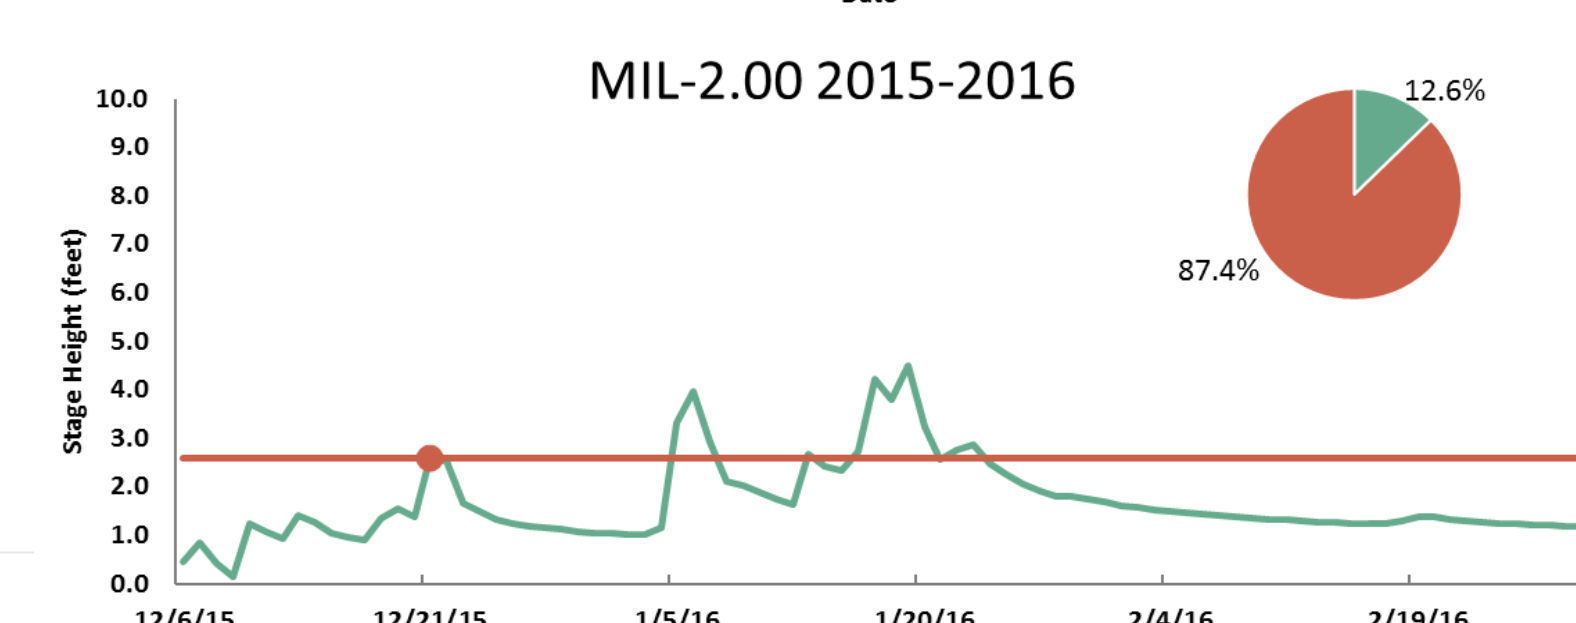
Graphs to the right show stage height during coho spawning season and adult PIT tag detections upstream of the dam for the winters of 2011/12 through 2015/16, prior to dam remediation. Each year, the coho spawning season began with the first significant rain event, usually in early winter, and extended through March 1. PIT-tag antenna detections were used to estimate the minimum stage height at which passage over the dam site was known to occur (passage line on graphs). The minimum stage height at which fish were detected upstream of the dam was 2.70' at MIL-2.99 and 2.60' at MIL-2.00. Pie charts show the percentage of the season when stream depth was above the minimum stage height at which fish were detected upstream of the dam. For 2011/12-2013/14 the MIL-2.99 gauge was used while in 2014/15-2015/16 the MIL-2.0 gauge was used.

**Prior to dam remediation:**  
In the winters of 2011/12 through 2015/16, daily average stream depth was above the estimated minimum stage height required for passage just 8.9% of the time.

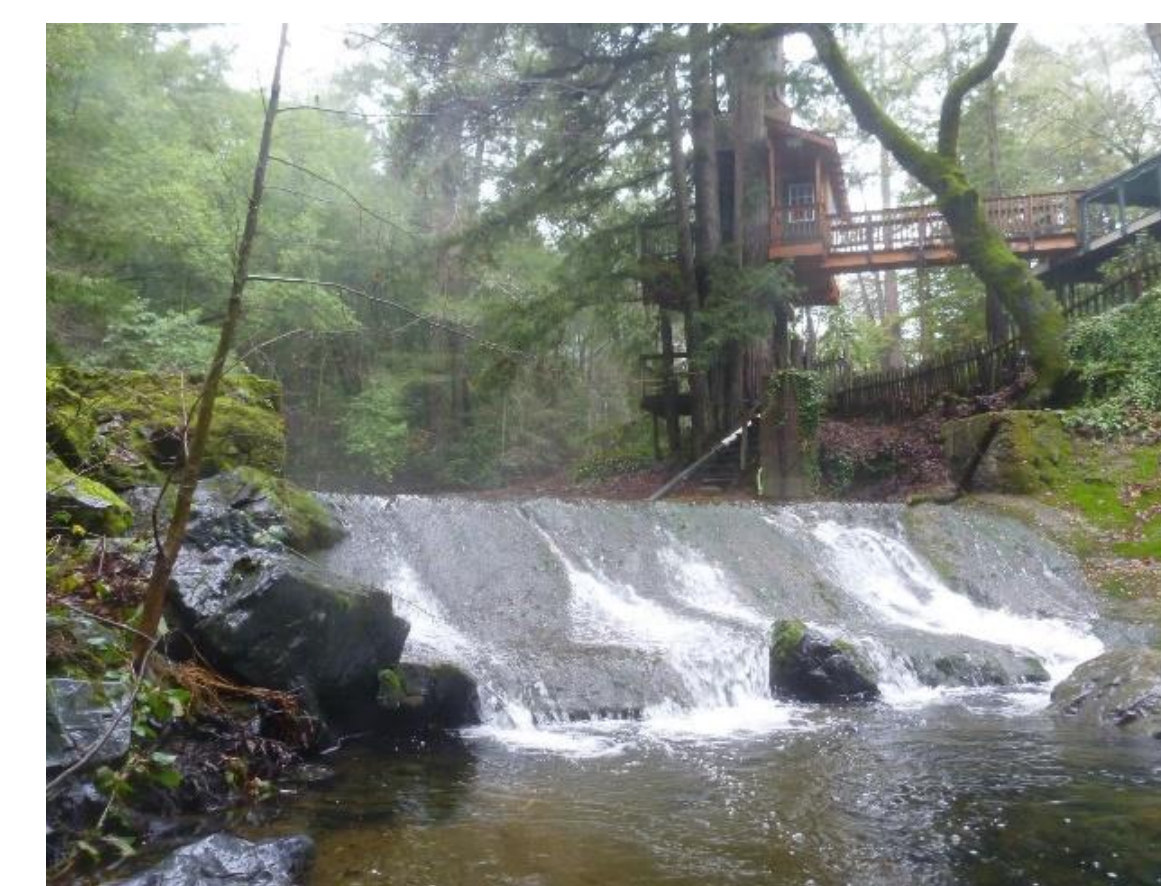
Dam before remediation.

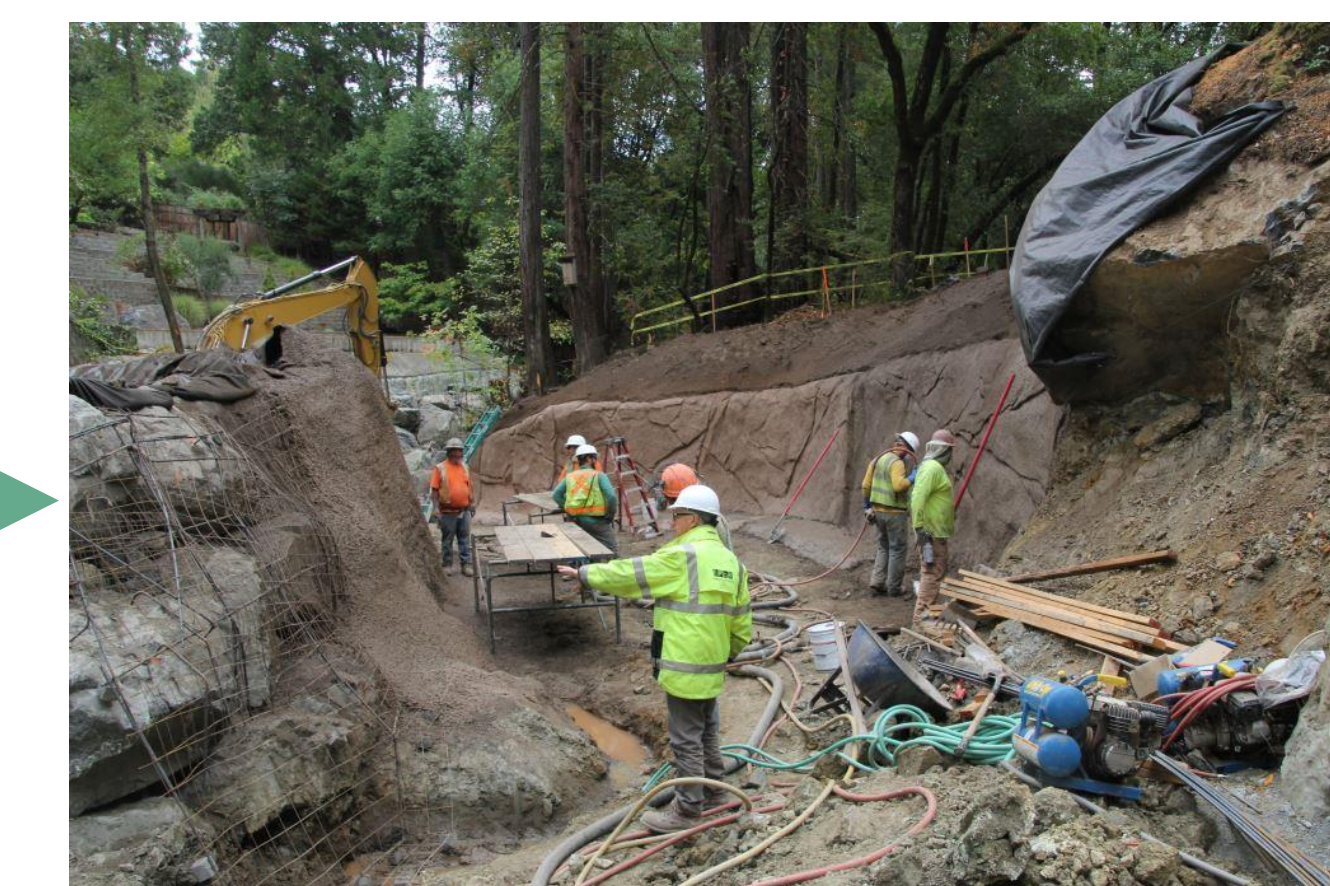
Passage project construction, October 2016

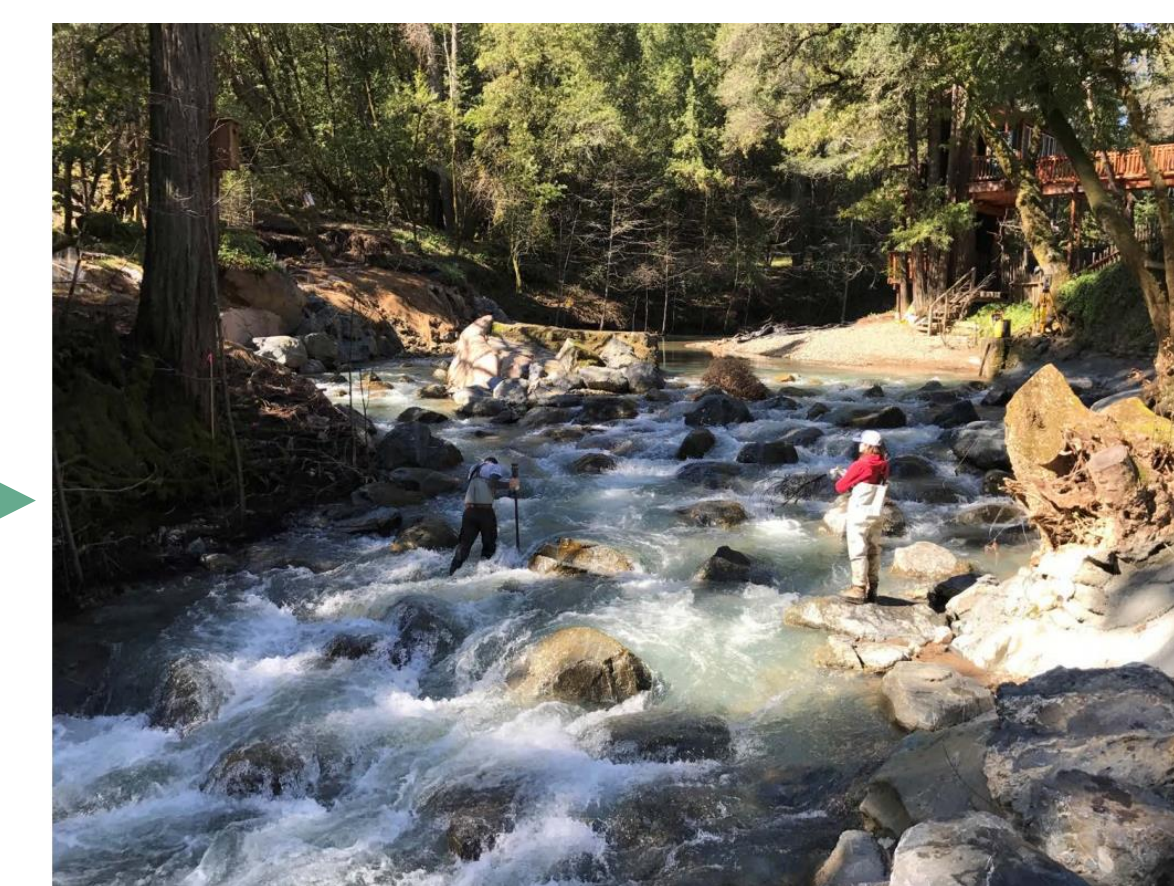
Post remediation, Winter 2016/17

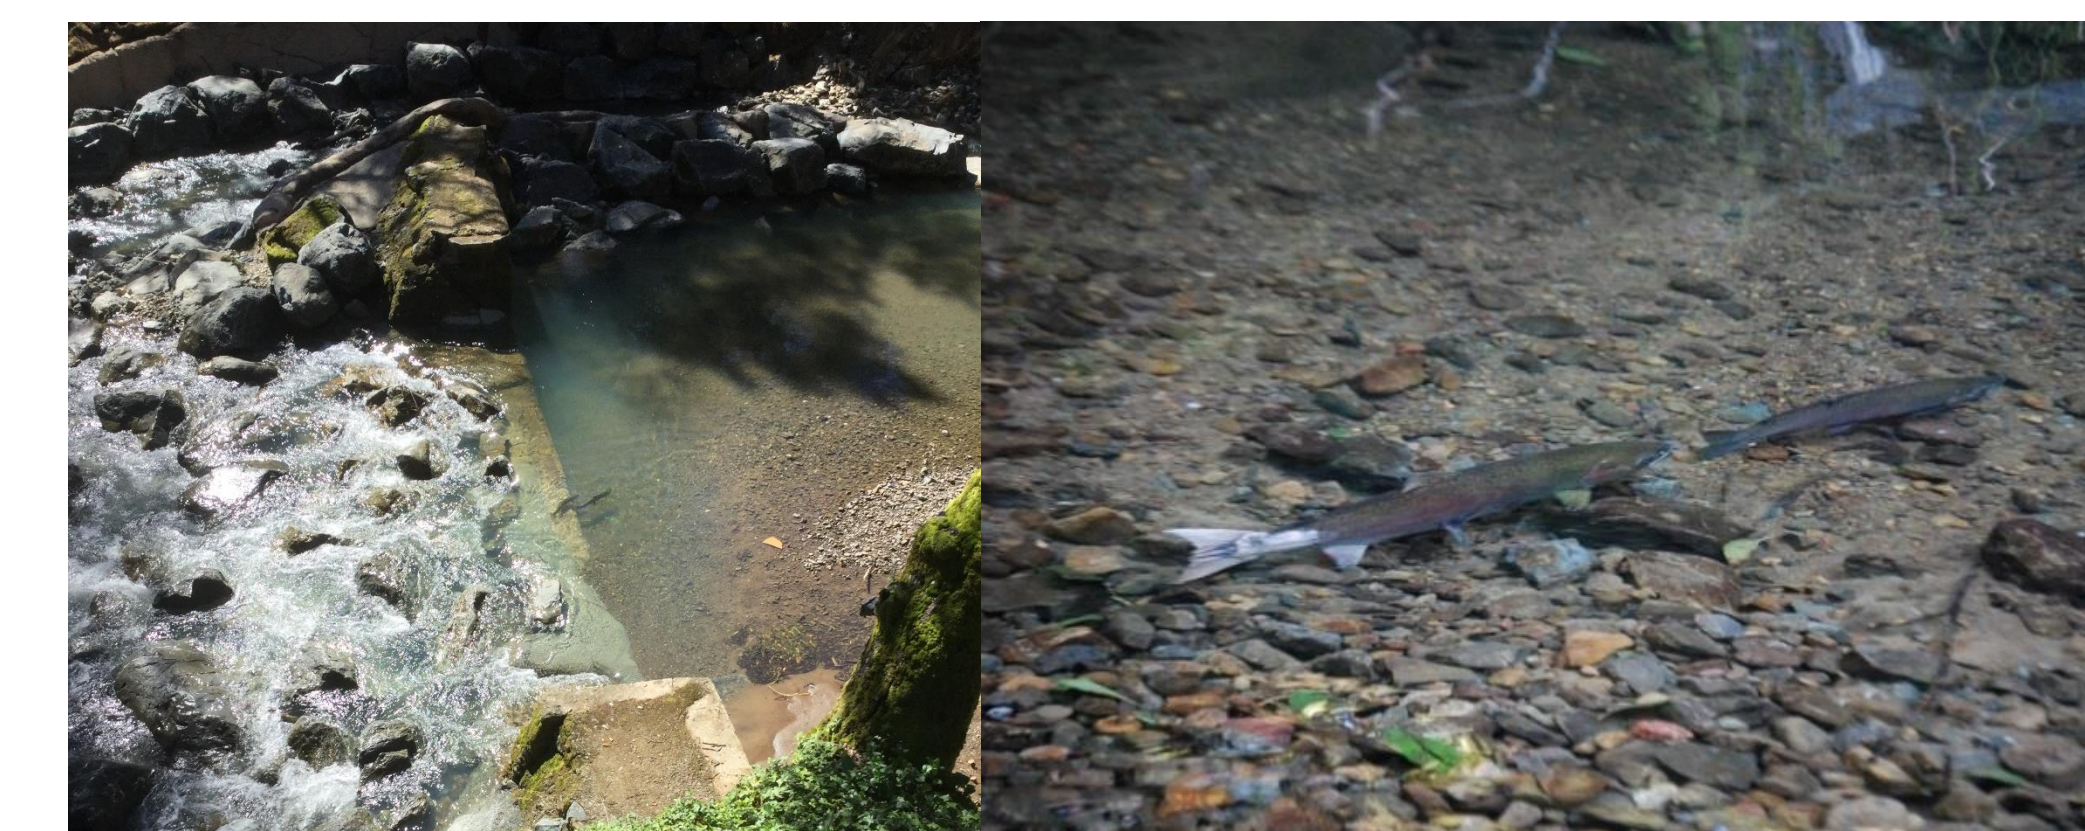
**Figure 8.** Adult coho and steelhead were observed above the dam site during the 2016/17 spawner season.

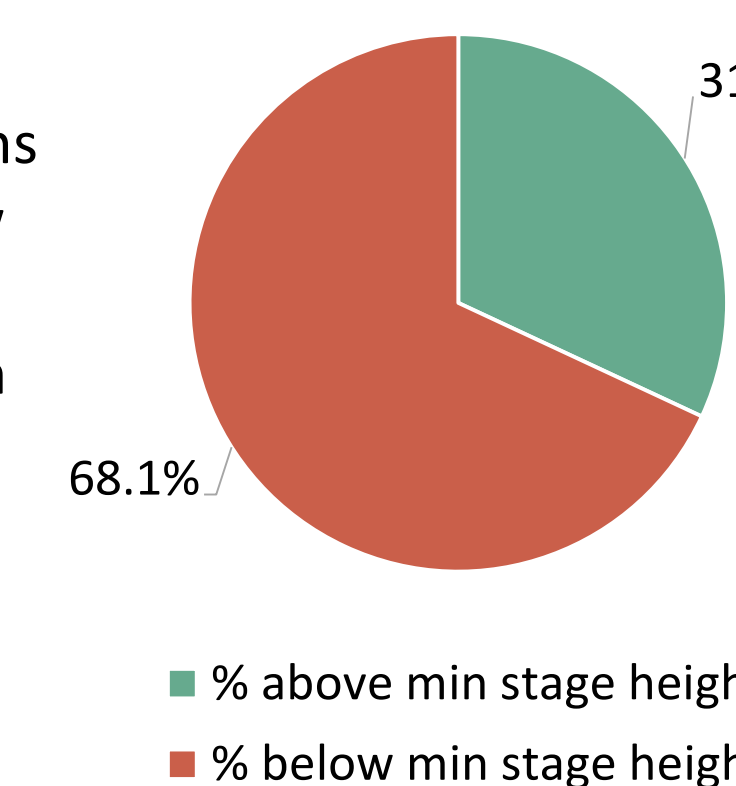
**After dam remediation:**  
In the winter of 2016/17, daily average stream depth was above the estimated minimum stage height required for passage 31.9% of the time.

Graphs to the right show, Winter 2016/17 PIT detections of adult coho occurred below the pre-project estimated minimum stage height, which decreased from 2.60' to 1.77' after dam remediation work. Stage data does not include dates after 1/3/2017 due to a technical failure.
