# Mark West Creek

## Environmental Monitoring Report WY2021 & WY2022

**MARCH 31, 2023**

Prepared for the Wildlife Conservation Board  
By: Trout Unlimited and California Sea Grant

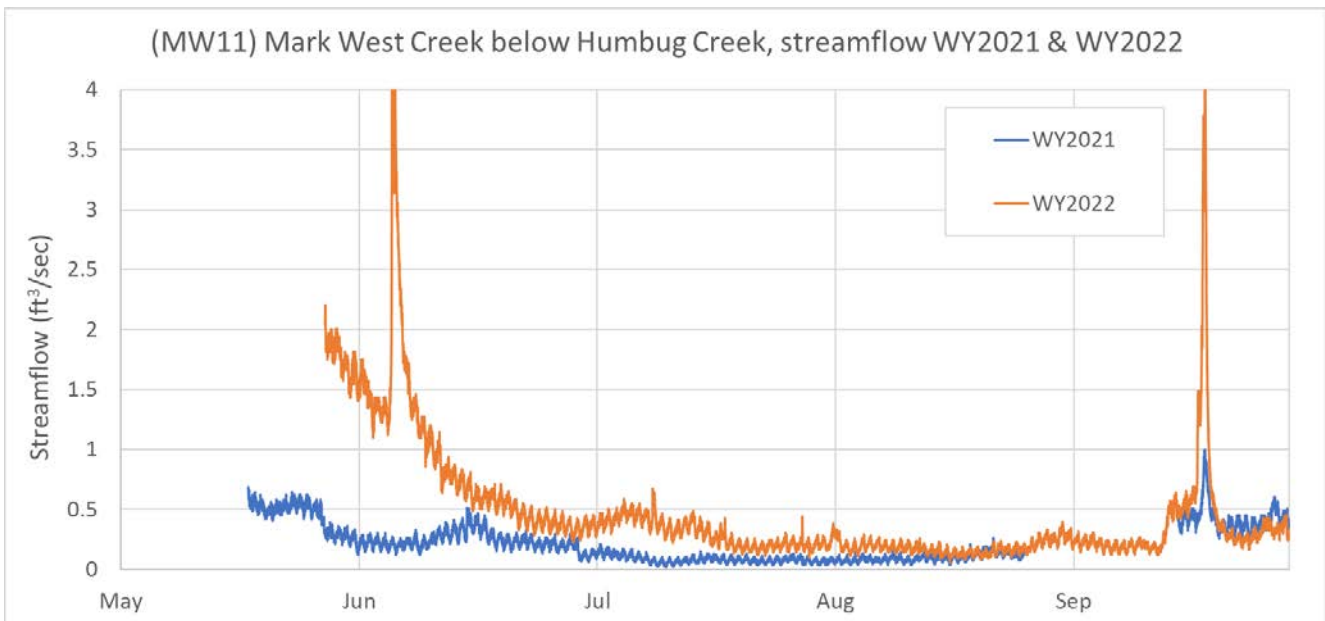
Figure 8. Streamflow at Mark West Creek below Humbug Creek, WY2021 and WY2022.

Figure 8 shows streamflow at at Mark West Creek above Van Buren Creek in WY2021 and WY2022. Streamflow in May 2021 started around 0.69 ft<sup>3</sup>/sec (at the time of the gage installation) and receded to 0.12 ft<sup>3</sup>/sec, and in May 2022 started around 2.2 ft<sup>3</sup>/sec (at the time of the gage installation) and receded to 1.4 ft<sup>3</sup>/sec. Due to technical difficulties, there is a gape in streamflow data in WY2021 from late-August through mid-September. Based on the data available, streamflow was higher in WY2022 than WY2021 through most of the summer, with the exception of mid-August when streamflow conditions in both years were near equal. Dips in streamflow on the order of 0.32 ft<sup>3</sup>/sec are detected occasionally throughout the summer, likely associated with a surface water diversion.

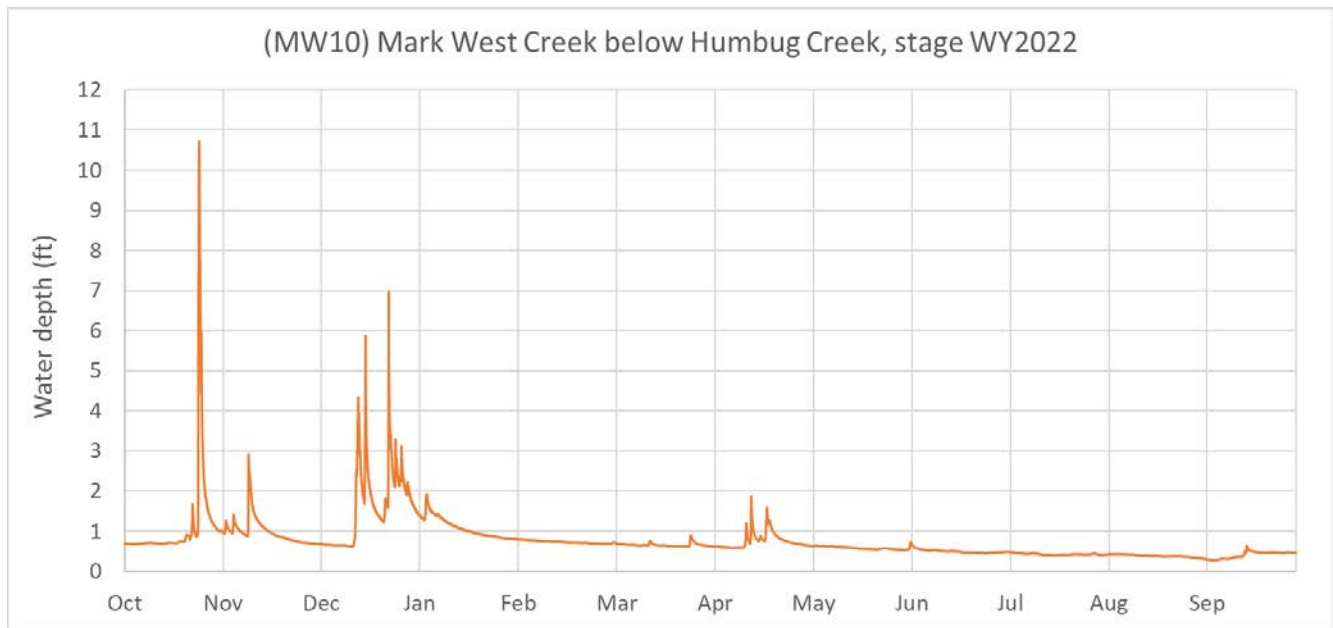
Figure 9. Stage at Mark West Creek below Humbug Creek, WY2022.

As with other sites, stage at site (MW10) Mark West Creek below Humbug Creek began to rise in response to the first storms of the year in late October 2021 (Figure 9). The highest peak flows of the year were observed on October 24, 2021, when stage rose to 10.6 feet. Stage began to recede in early January, then rose in response to small storms in April. A low stage of 0.27 feet was reached in September 2022.

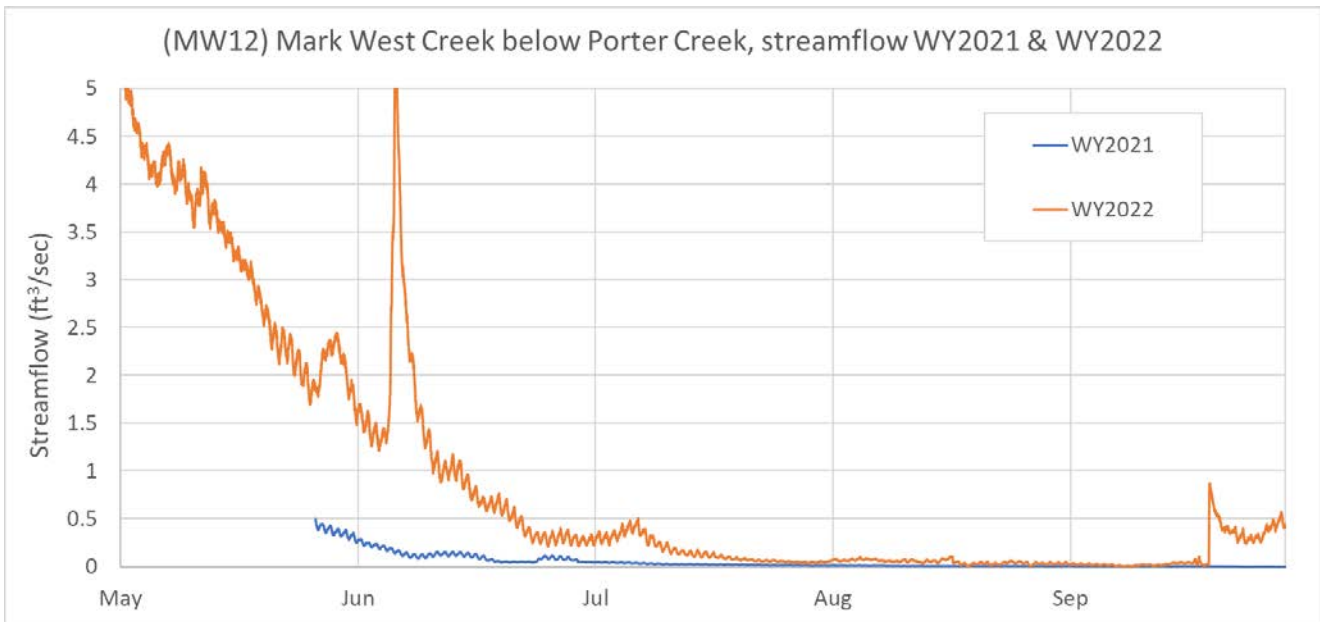
Figure 14. Streamflow at Mark West Creek below Porter Creek, WY2021 and WY2022.

Streamflow at Mark West Creek above Porter Creek was lower than the upstream site MW02, for later portion of the summer. Figure 14 shows streamflow conditions at Mark West Creek below Porter Creek in WY2021 and WY2022. Streamflow in May 2021 was approximately 0.45 ft<sup>3</sup>/sec (at the time of installation) and in May 2022 started around 5 ft<sup>3</sup>/sec and receded to 1.48 ft<sup>3</sup>/sec. Streamflow was higher in WY2022 than WY2021 through mid-August. By mid-August 2022, streamflow reached a very low baseflow of approximately 0.02-0.01 ft<sup>3</sup>/sec.

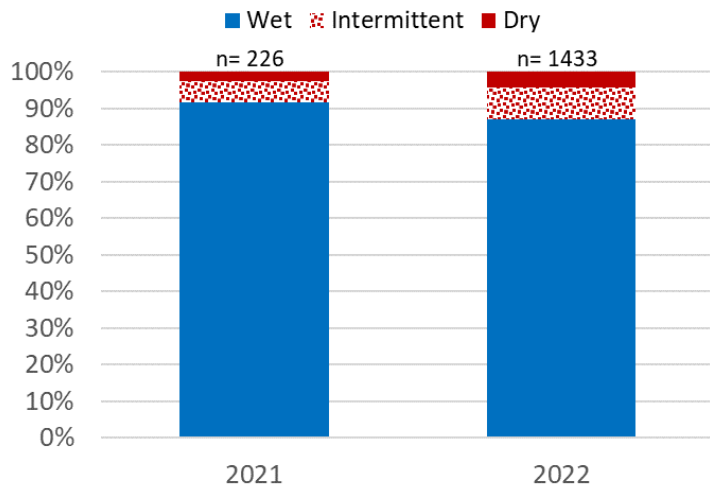
Figure 35. Proportion of minimum counts of juvenile salmonids, both coho salmon and steelhead, in relation to driest wetted habitat conditions (September) in Mark West Creek, summers 2021 and 2022.

In both years, the vast majority of rearing fish were documented in locations that maintained wet and connected habitat. Despite there being slightly more available wetted habitat in the study reaches during the

driest sample of 2022 than in 2021 (95% and 92%, respectively), 5% more coho salmon and steelhead yoy were observed in areas that remained wet and connected through the dry season in 2021 (92%) than in 2022 (87%) (Figure 34).

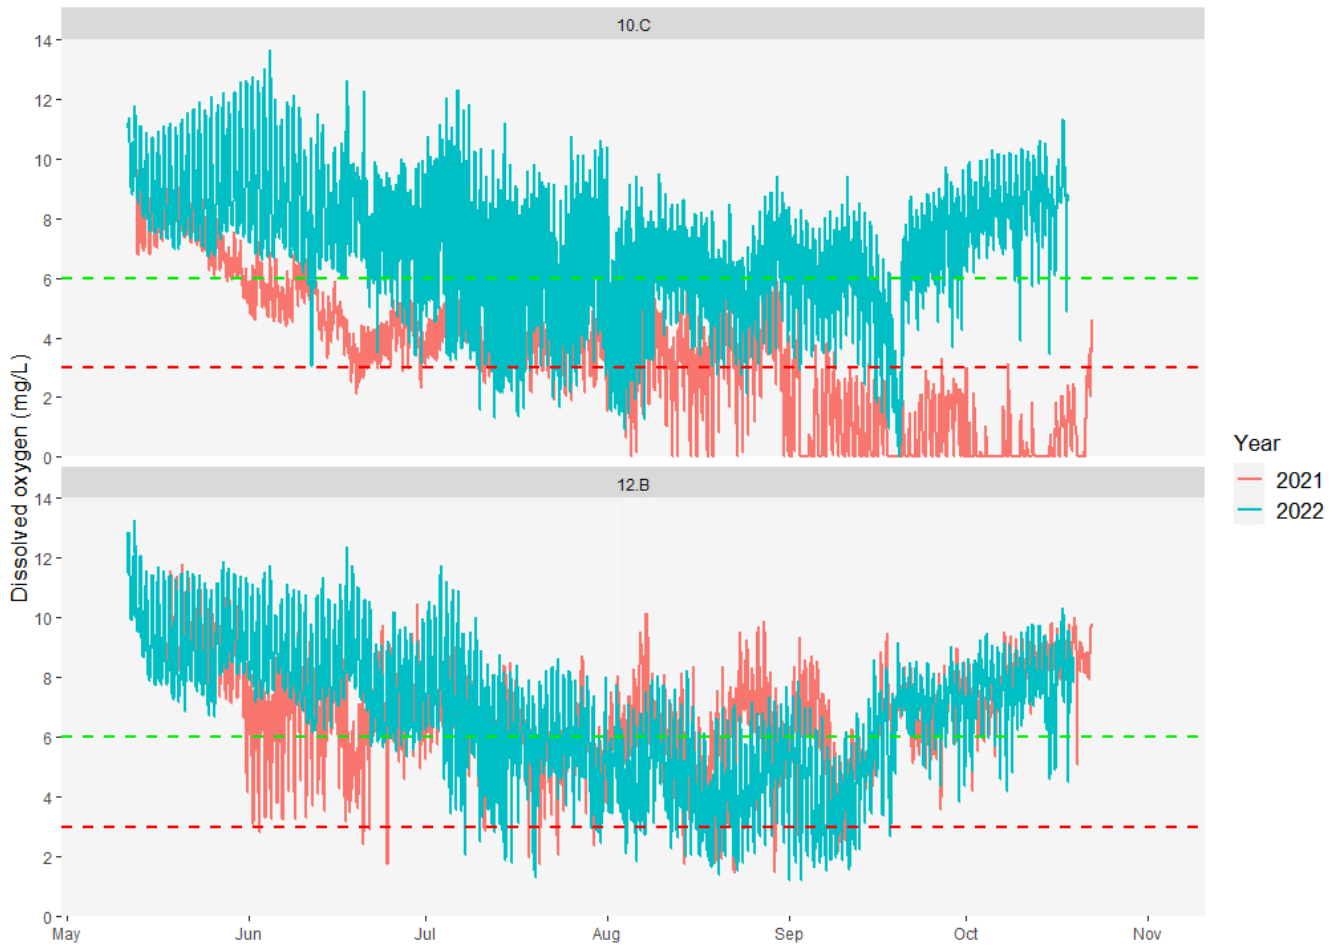
Figure 37. Mark West Creek continuous dissolved oxygen at sites 10.C (top panel) and 12.B (bottom panel), summers 2021 and 2022. Dashed green line represents the regional daily minimum objective of 6.0 mg/L and the dashed red line represents the mortality threshold of 3.0 mg/L.

Continuous DO concentrations provided relief for fish in both years at site 12.B. Though the daily minimum objective was met only 29% and 35% of sample days in 2021 and 2022, respectively, daily maximums often exceeded 6.0 mg/L (Table 3, Figure 36). This same pattern, of continuous DO concentrations providing relief from the daily minimums, has been observed in other Russian River tributaries, such as Green Valley and Mill creeks. In both years, continuous concentrations at site 12.B in Mark West Creek began increasing in mid-September and continued to generally increase until the end of the monitoring period.

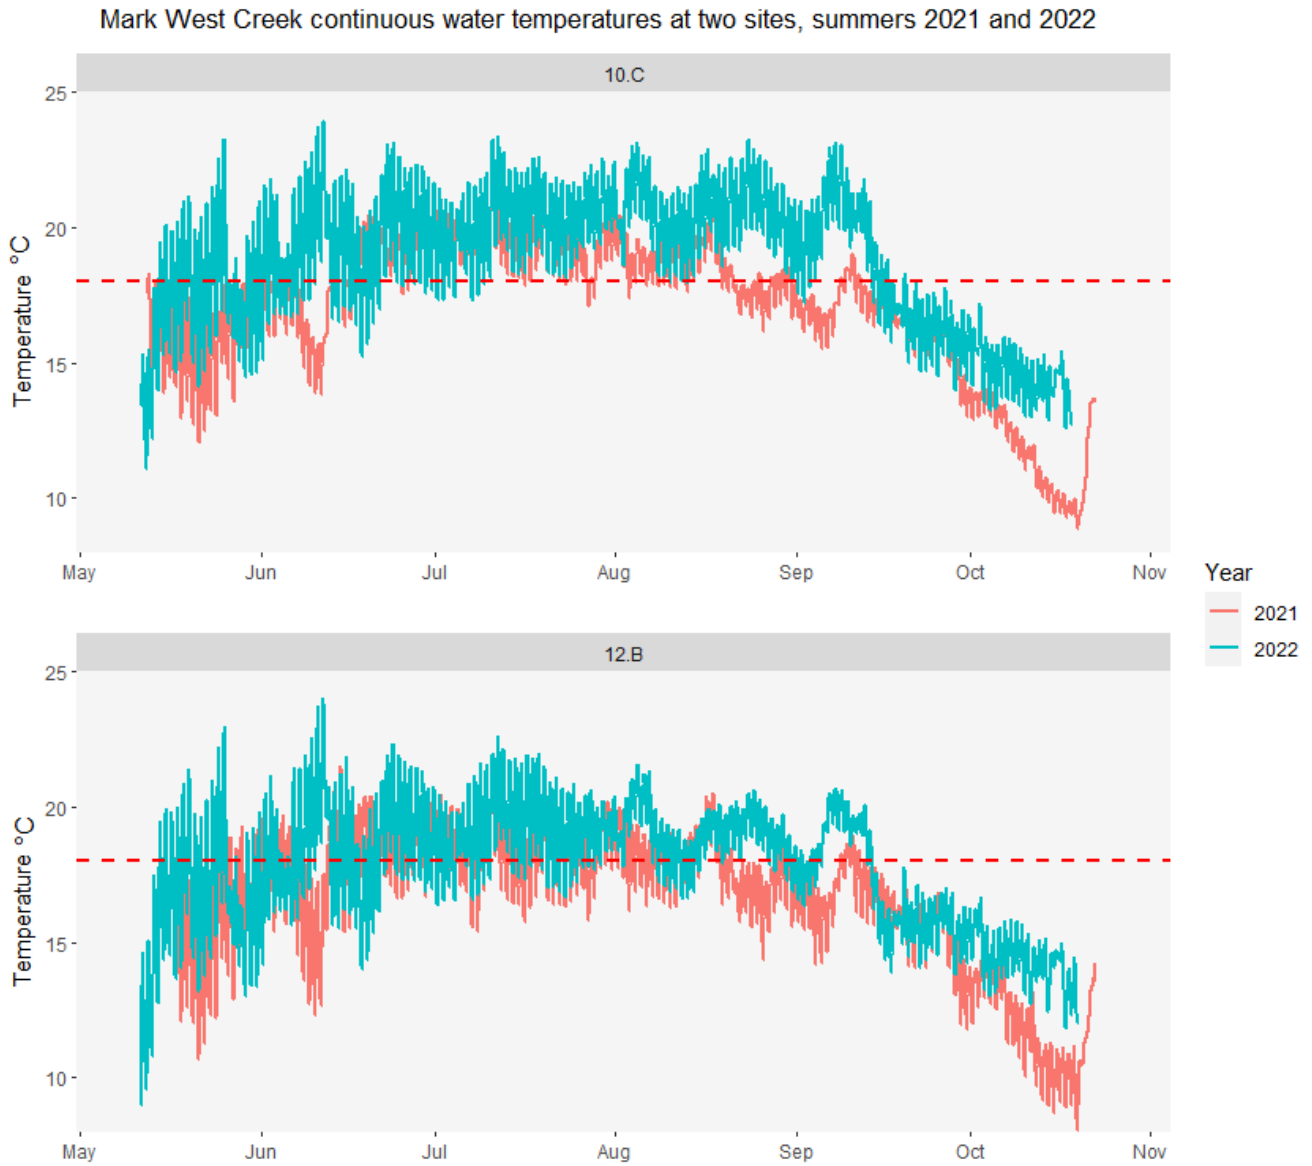
Figure 40. Mark West Creek continuous water temperatures at sites 10.C (top panel) and 12.B (bottom panel), summers 2021 and 2022. Dashed red line represents 18 °C avoidance threshold.

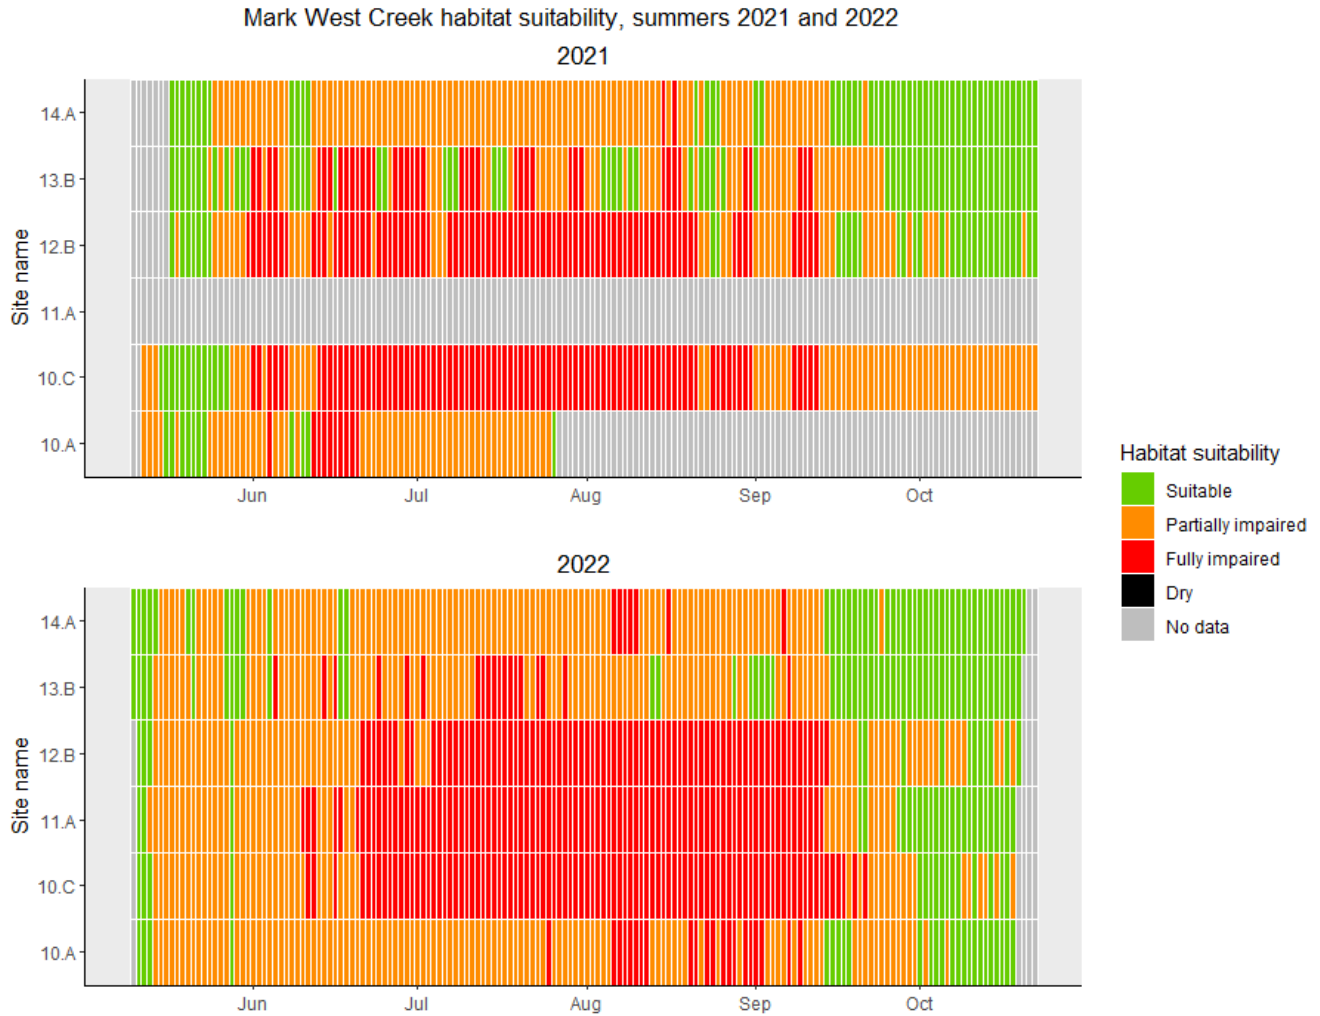
Figure 41. Habitat suitability at logger sites in Mark West Creek from May 10 to October 20, 2021 (top panel) and 2022 (bottom panel). Each tile represents one day, for a total of 166 days per site, per year. The habitat was considered suitable if it was wet and met both the DO and temperature thresholds. Partial impairment describes habitat that is wet but does not meet one of the two water quality thresholds. Full impairment indicates that neither the DO or temperature objectives were met, but the pool retained water. If there was no water in the sample pool, it was designated as dry. Days with no data are shown in grey. The dataset for site 10.A in 2021 ends mid-season due to a logger deployment error, and no data were available for 11.A in 2021 due to the loss of the logger during a storm event.

There does appear to be a spatial trend in habitat suitability, with the worst sites in the middle and lower sections of the study area. There is also a strong temporal trend; the onset of partial or complete habitat impairment began in June at all sites, in both years. There was a slight delay in the onset of full impairment in 2022, compared to 2021, by approximately two weeks (Figure 40). This delay was likely caused by a rain event that increased flows in the first week of June, 2022 (section 3 and 4). Generally, once conditions became fully impaired, they remained impaired until the end of the dry season. In all cases, conditions gradually improved as the dry season came to a close and flows began to increase with minor rain events and reduced evapotranspiration demand.
